## Pop Coming from Both Sides of the Rear Roof Area

| Year | Model | Trim Level |
|---|---|---|
| 2019–22 | RDX | ALL |

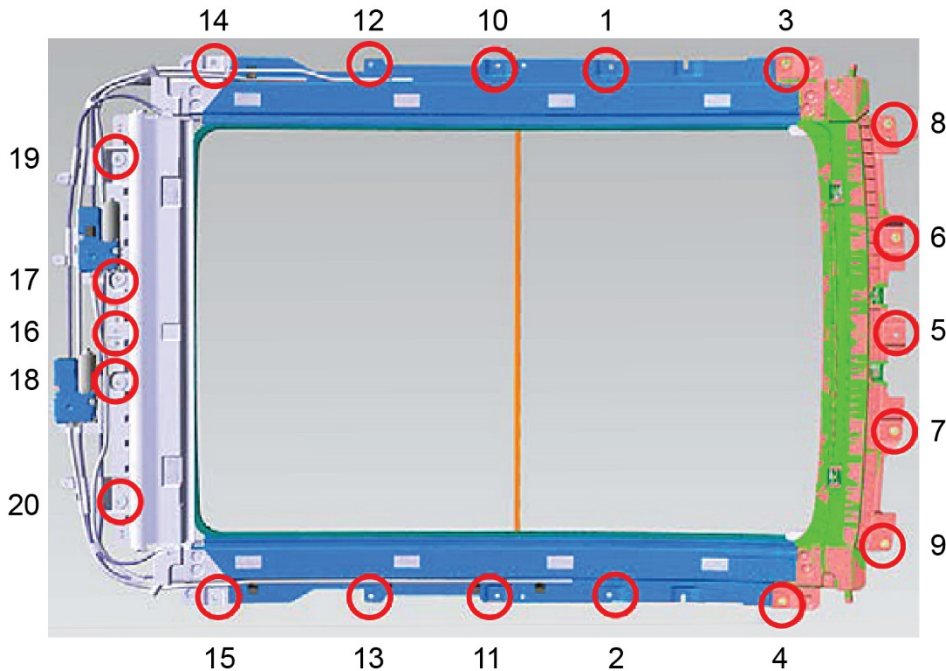
We are getting reports of a popping noise coming from the left and right sides of the rear area of the roof near the panoramic sunroof assembly.

Before replacing the sunroof frame assembly to address the noise, do a mounting bolt retorquing procedure. Then, verify if the noise is still present before replacing the frame assembly.

Follow the service information procedure, **Headliner Area Removal** to remove the headliner. Once the headliner is removed, all 20 sunroof assembly bolts will be accessible. Then, by following the torque pattern below, make sure each bolt is torqued to spec **9.4 N.m (6.9 ft-lb)**.
