## Mack Chassis - Models GU / GR - Constant Correction To Center

### GU/GR, CHU, CXU, AN Constant Correction To Center

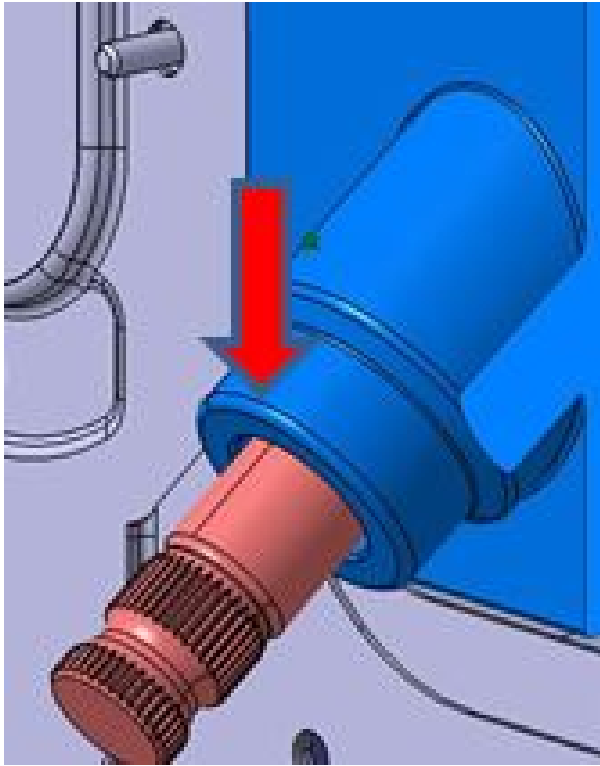
- For GU vehicles produced **prior** to 1<sup>st</sup> week of January 2017. A change of the upper steering column happened in November of 2014 (4mm shorter). With this change we believe an interference may be present with the column boot on the cab wall. This may create undue pressure on the column shaft as it comes out of the cab wall.

- Pressure from the boot may be applied to the steering column shaft restricting it from turning freely. To check, disconnect upper steering shaft at base of column shaft. Remove boot (there may be a noticeable movement upward of the shaft). Reassemble steering shaft to steering column and test drive. If problem is resolved replace boot with 84723313 (Introduced into production 2017w01). Test drive after boot replacement to ensure problem is resolved before returning truck to customer.

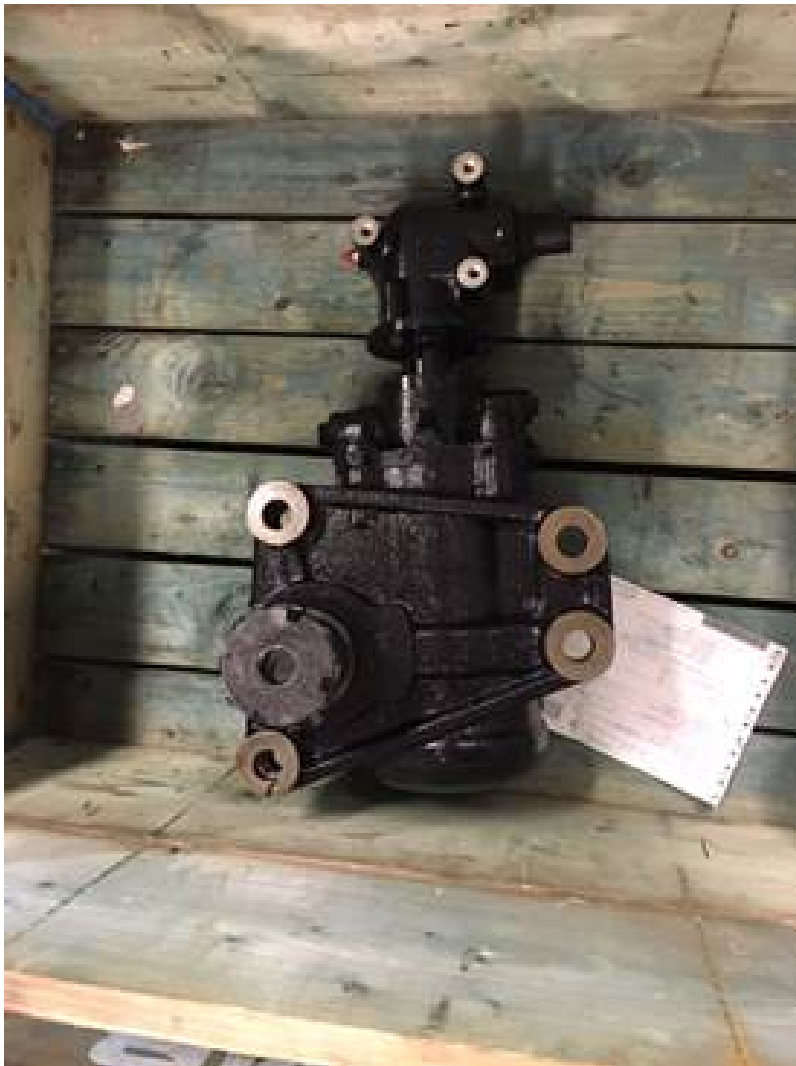
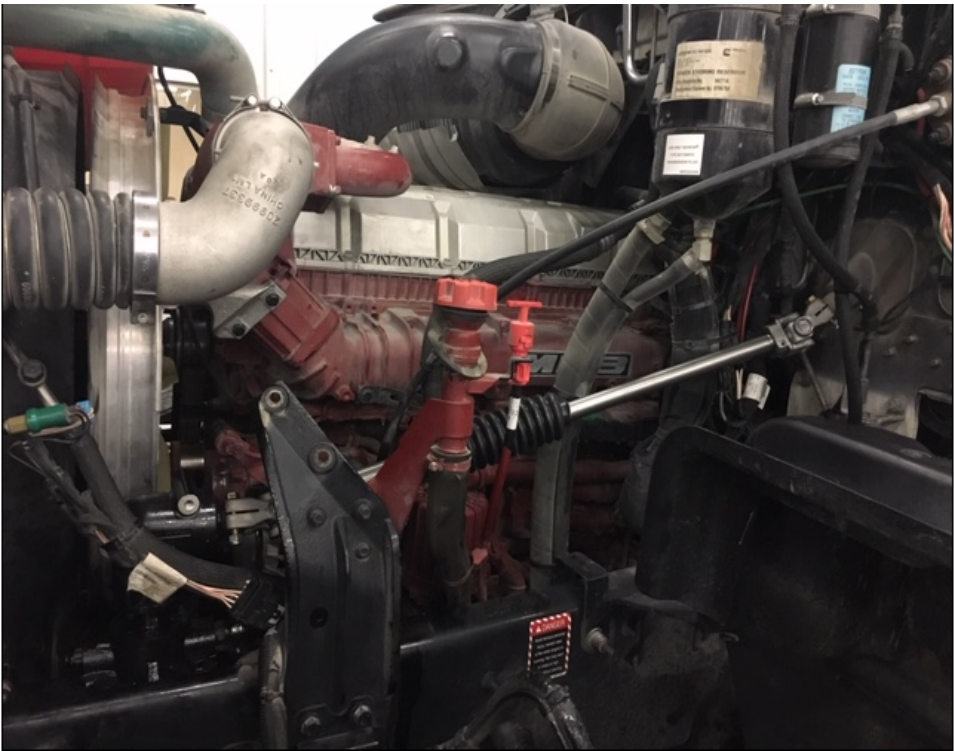
Live UI On non-assist gear trucks we have a steering gear from Sheppard with a 90° miter box on top. This can be used with an Anthem 1

piece steering shaft.

- Sheppard steering gear part # 8148-SD110PAE3.
  - Steering shaft 84703023 x 1.
  - Screw 25106380 x 2.
  - Nut 25098472 x 2.
- Follow Impact service procedures for gear and shaft replacement.
  - Clearance to any component must be a minimum of 1".
  - Pillow block bearing bracket may be left in place and trimmed off or not.
  - Slightly stiffer steering may result. May improve as components wear in.
  - Use [84734967](#) as the causal part in the claim.
