Tech Tool Returns Error Code 140 Failed To Run On-Vehicle Test; Programming, Calibration, Or Test Operations Fail In Premium Tech Tool (PTT), PTT Displays Control Unit Information Correctly - US10+OBD13 And Newer Emissions, Common Model Year 2014 And

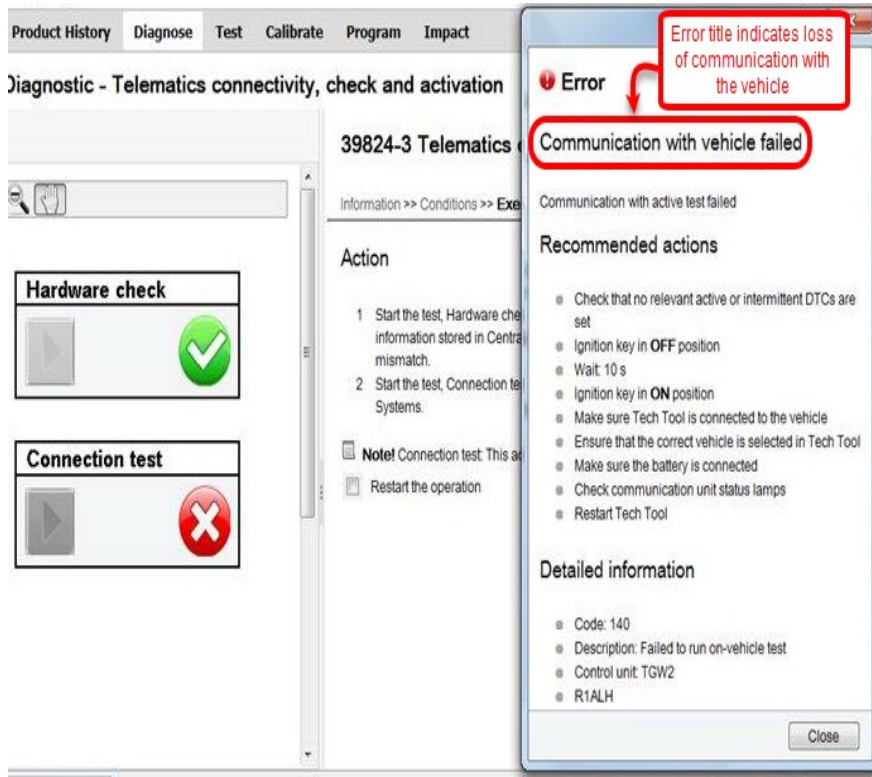
- In the example shown below, the flash screen in PTT looks like the ECU software is sending the error code because it is processing a Routine—R1ALH—that is being run when the

Live UI failure is detected.

- The actual message is indicating loss of communication with the vehicle.

- The recommended actions give a high level list of general items that could be tried to correct the issue.

- If the recommended actions do not correct the problem then the individual circuits to the specific ECU that is being tested should be investigated as outlined below.
