#### 90 Instrument cluster: trip odometer and/or clock sporadically resets to zero 90 22 39 2064301/2 January 28, 2022. Supersedes Technical Service Bulletin Group 90 number 21-12 dated August 19, 2021, for reasons listed below.

Model(s)	Year	VIN Range	Vehicle-Specific Equipment
Q3	2021	All	All

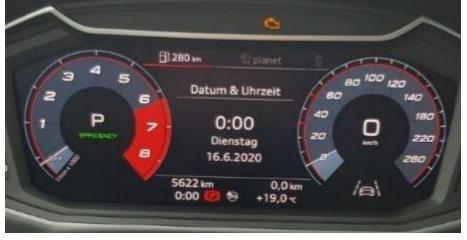
• The trip odometer and/or the clock in the instrument cluster will sporadically reset to zero (Figure 1).

Figure 1. Clock and trip odometer reset to zero.

A software issue in the instrument cluster can cause it to reset on start-up clearing the clock and trip odometer.

- 1. Follow all instructions in TSB 2011732: 00 Software Version Management (SVM), operating instructions.
- 2. Update the instrument cluster, J285 (address word 0017) using the SVM action code as listed in the table below, if necessary:

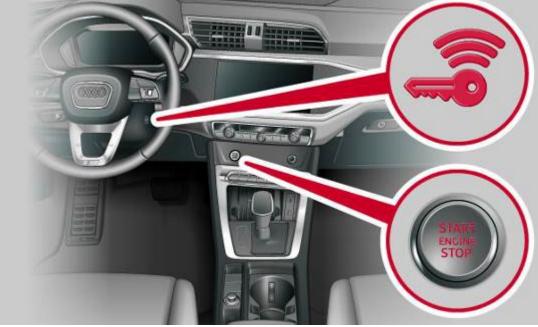
Figure 2. Key reader coil location.

• Affix the vehicle key to the key reader coil before starting the update (for example with adhesive tape), then turn on the ignition (Figure 2).
