Technical Service Bulletin

90 Audi virtual cockpit: display distorted due to broken screen
90 22 43 2065960/1 January 31, 2022.

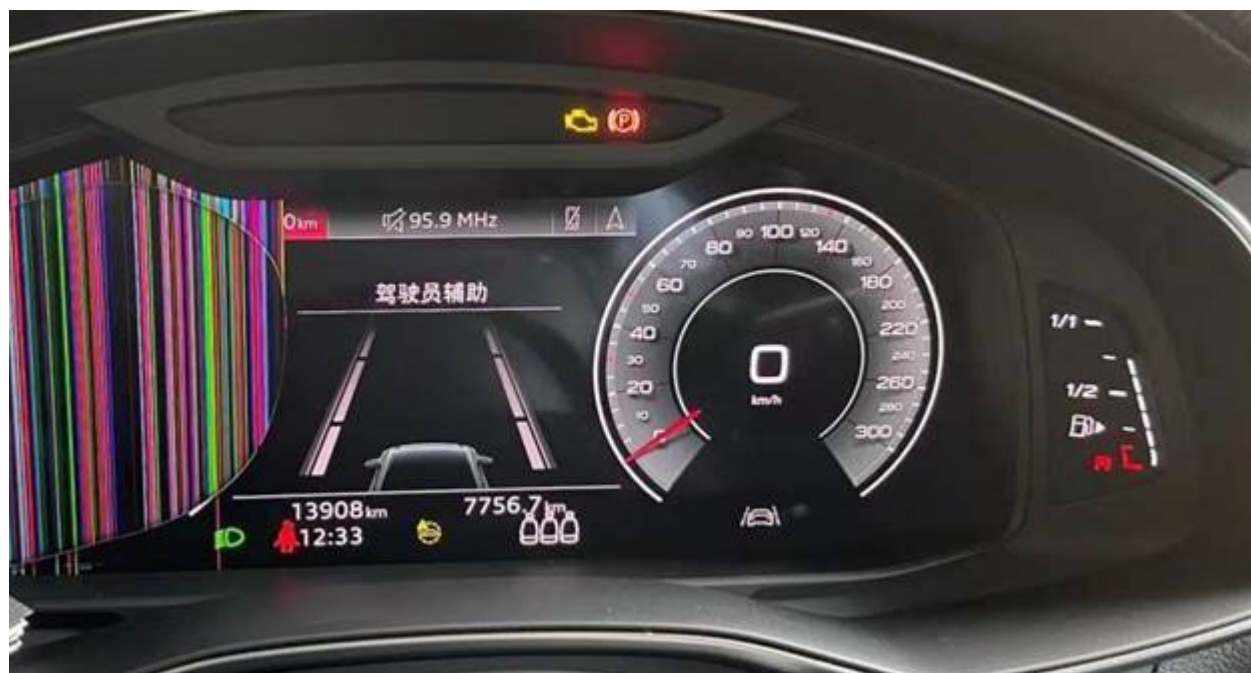
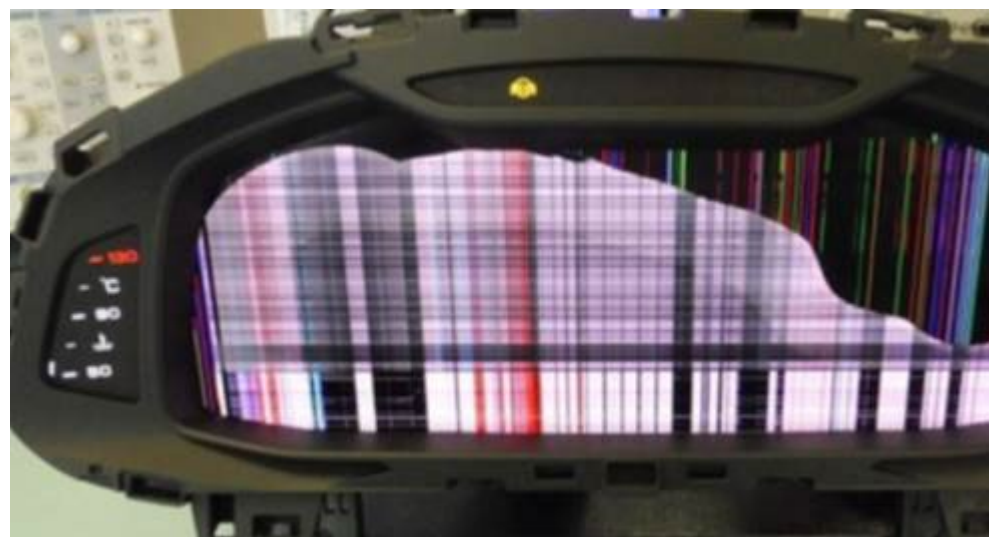
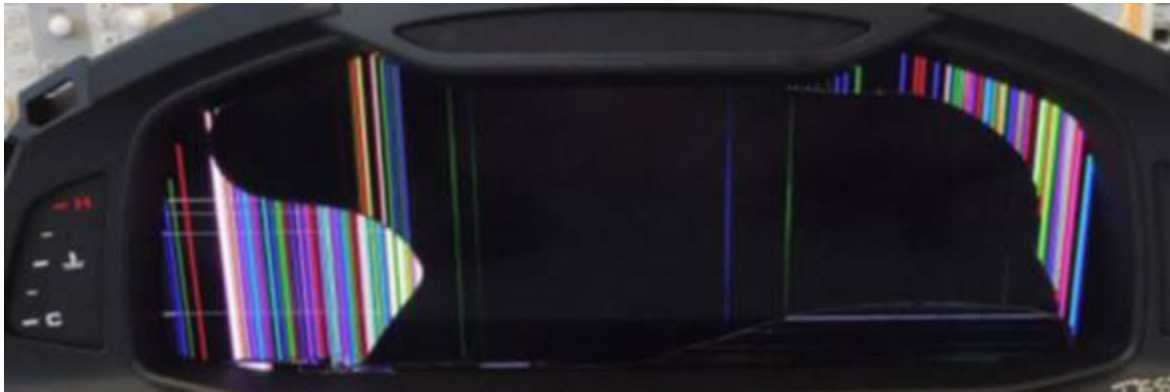
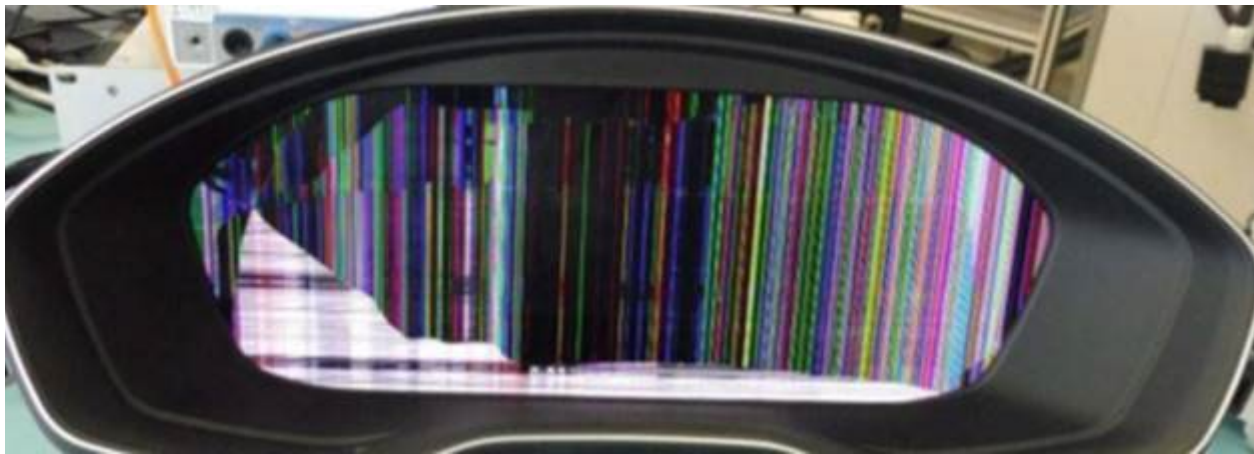
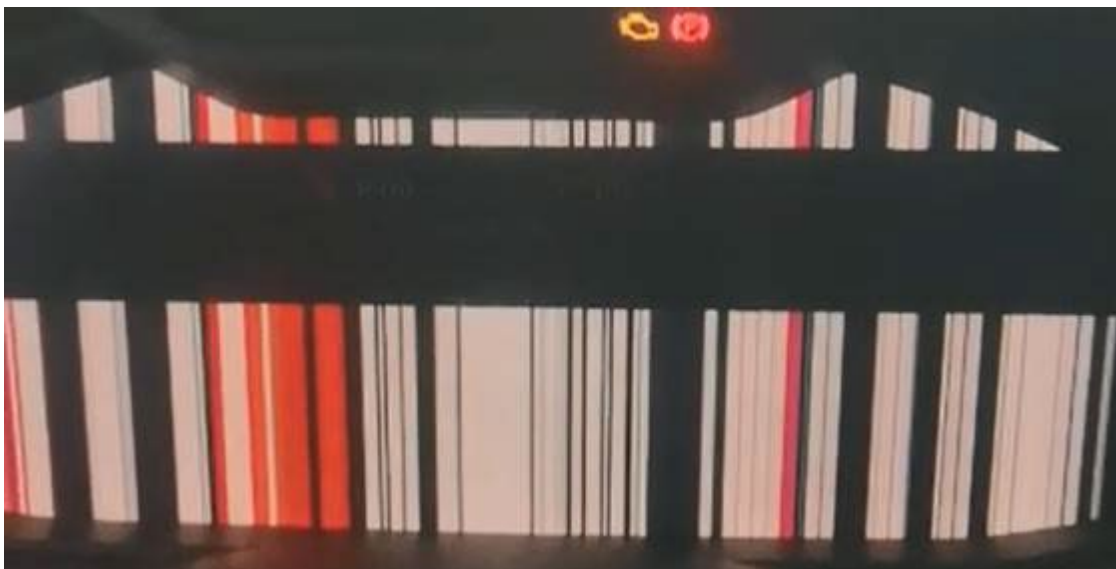
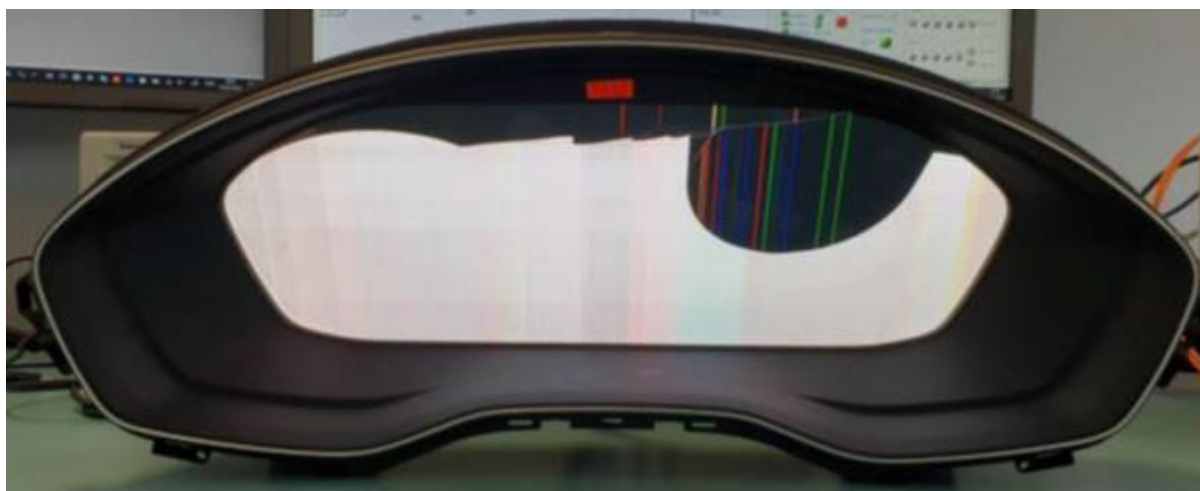
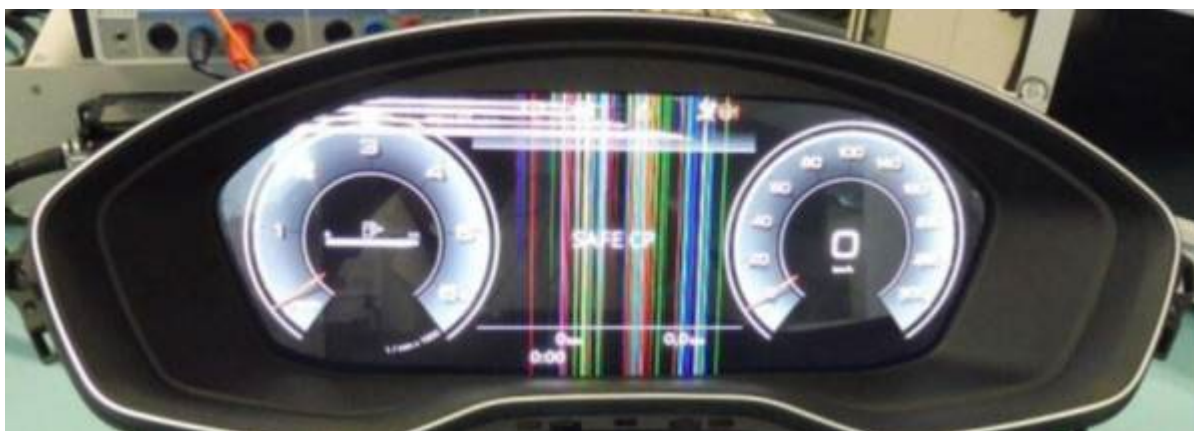
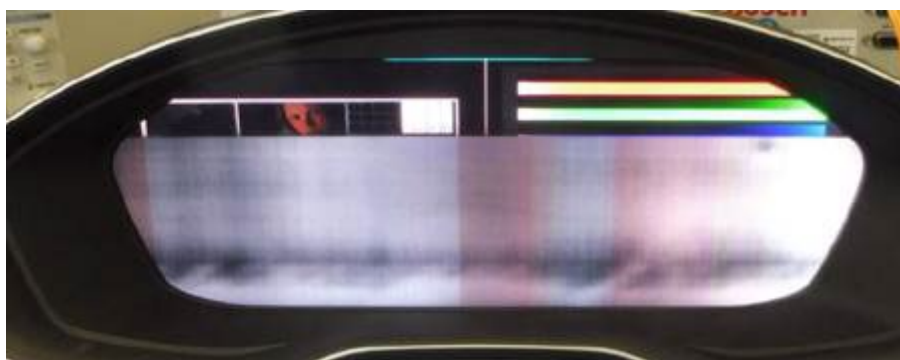
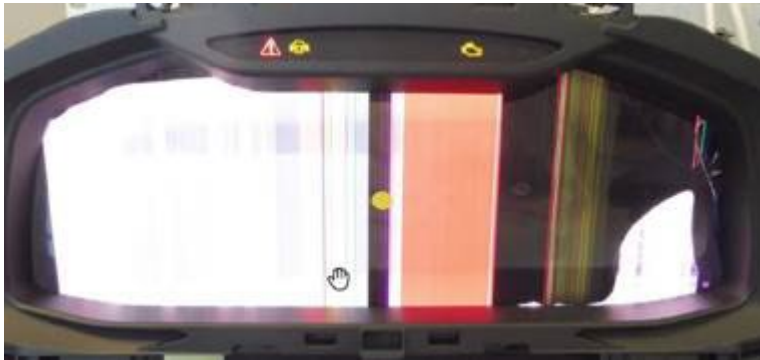
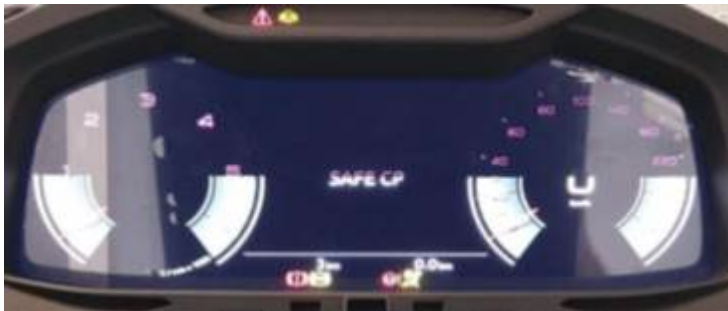
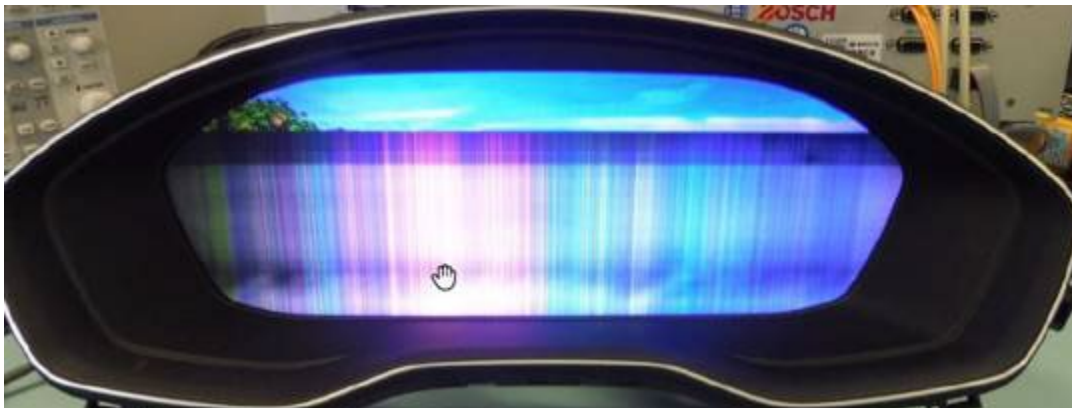
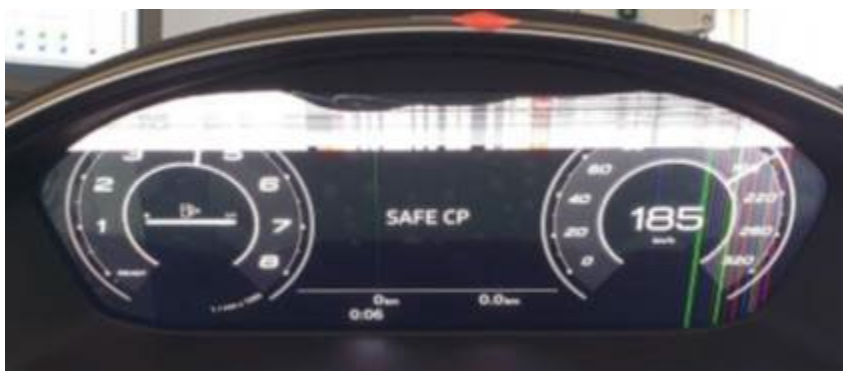
The Audi virtual cockpit display is distorted.

There are cracks in the Audi virtual cockpit display.

The following photos show examples of the complaint:

Extensive analysis has shown that the display layer under the uppermost display film has a crack.

This crack is the result of external force being applied to the display of the Audi virtual cockpit, either directly to the front of the screen, or to the display housing.

While the uppermost display layer, the transparent film, is not broken or cracked, it may show witness marks where the force was applied (e.g. fingerprints, scratches, polishing marks)

The external force which caused the crack and the complaint may have been exerted during improper cleaning of the Audi virtual cockpit, repair work on the dash panel, an accident or a user incorrectly assuming that the display of the Audi virtual cockpit has the functions of a touchscreen.

The complaint may not be visible right after excessive force was applied, as the lower display layer may be damaged and experience fatigue cracking as a result of the initial force event. This may take a couple hundred miles of driving.
