Technical Service Bulletin

91 MIB2 High: Audi Smartphone Interface (ASI) does not work after reversing
91 22 68 2053226/2 January 18, 2022. Supersedes Technical Service Bulletin Group 91 number 18-22 dated December 10, 2018 for reasons listed below.

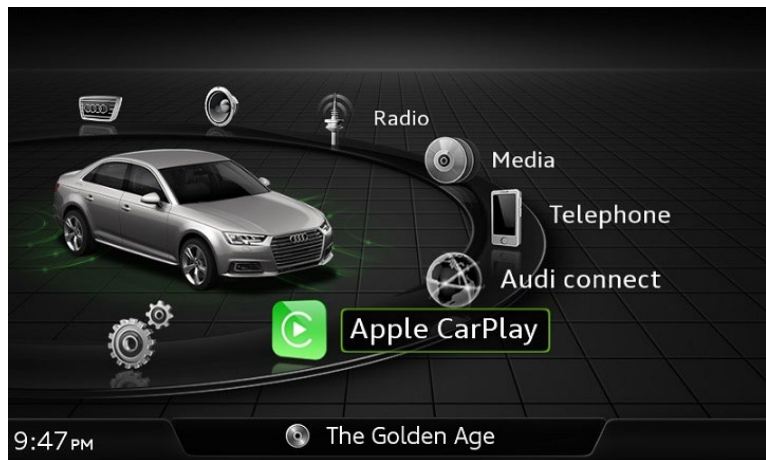
- After driving in reverse, the Audi Smartphone Interface (ASI) menu can no longer be selected, although the music is still playing (Figure 1).

Figure 1. ASI menu cannot be selected anymore.

The software needs to be updated.

Update the MIB2 High infotainment system using either Method 1 or Method 2 according to TSB 2047576: *91 MIB2 High Software Update Instructions (PR Code 7UG)* and use SVM code indicated below:
