Instructions for navigating the document

Index of models

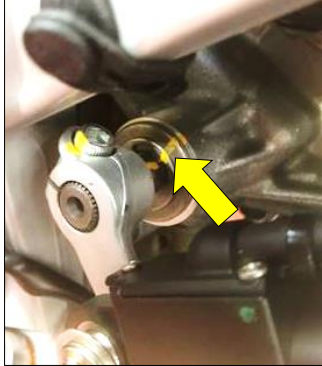
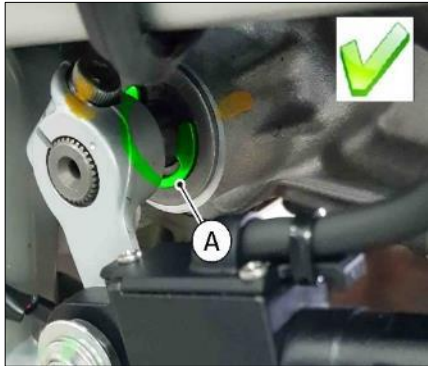
2	<p><u>ONLY</u> <u>Panigale V4</u> <u>(all versions)</u> <u>Streetfighter V4</u> <u>(all versions)</u></p> <p>Introduction of gear selector shaft certification</p>	Gear selector

<p>We have received some isolated reports of a possible loss/absence of the snap ring (A) of the gear selector shaft. We would like to inform you that an additional certification on all Desmosedici Stradale engines between snap ring, washer, and crankcase at the outlet of the gear selector shaft has been added along the production line. The first engine serial number with this new certification is ZDM1100WC #001513#.</p> <p>Upon the first workshop service, you are thus invited to check for the presence of the snap ring (A) on all engine serial numbers preceding the one specified above.</p> <div data-bbox="1771 1067 2197 1434">

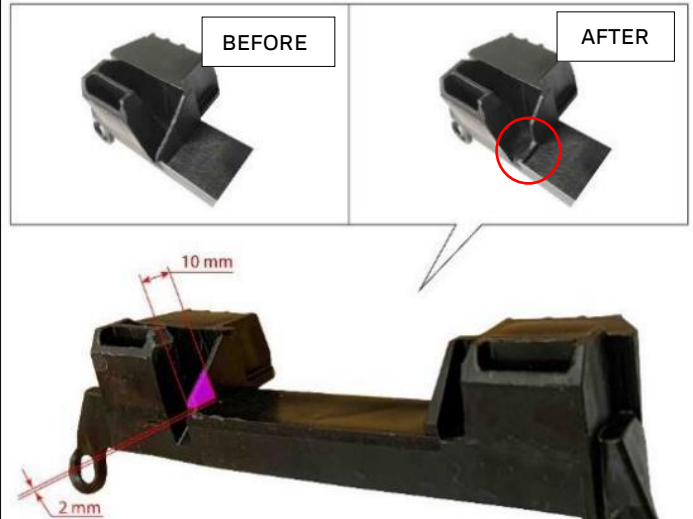
<p>When mounting the rider seat in "high configuration", an excessive gap can be seen between the lower trim and the RH side panel. This is due to interference between the central riser and its support. To avoid such interference and therefore improve the coupling between the rider seat and the side panel, it is necessary to:</p> <ol style="list-style-type: none"> 1) Remove the center riser from the seat; 2) Working on the RH side support, remove the excess material with a cutter, as shown in the figure. 3) Reinstall the center riser to the seat.
