Technical Service Bulletin

94 Steering warning displayed in the instrument cluster
94 22 55 2065605/1 January 7, 2022.

Model(s)	Year	VIN Range	Vehicle-Specific Equipment
A6, A6 allroad, S6, RS 6, A6 Avant, RS 6 Avant, A7, A7 PHEV, S7, and RS7	2019 – 2022	All	Not Applicable

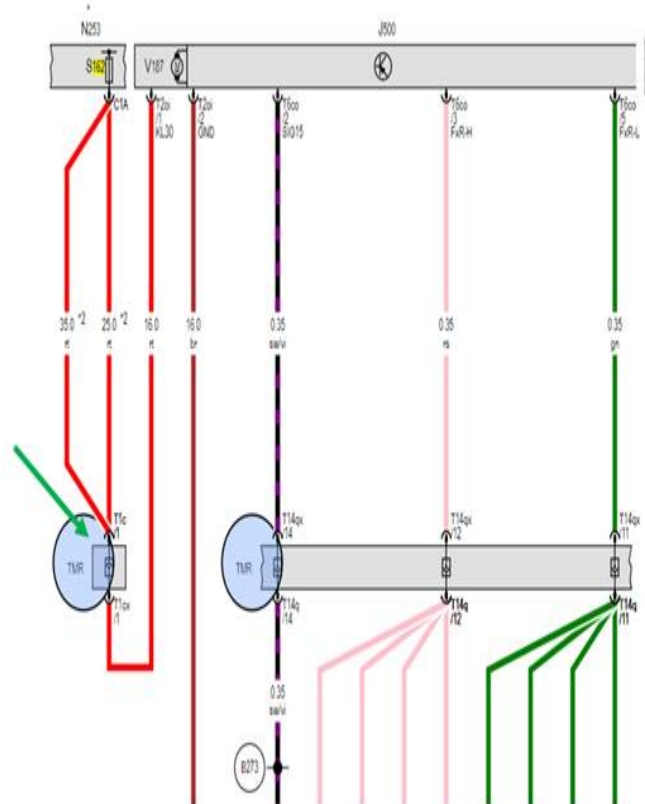
1. During diagnosis of a steering warning concern, connector T1c/T1cx at the TMR station is found to be oxidized.

Figure 1: Connector station to be inspected.

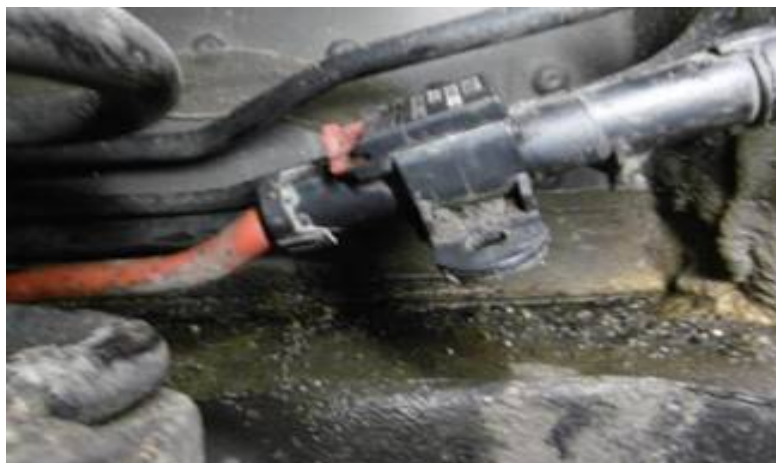
- There are various DTC's stored relating to the power steering module, J500 (diagnostic address 0044).
- Coupling point (TMR T1c/T1cx) to the electromechanical steering rack is oxidized.

The contact in the connector housing oxidizes due to moisture ingress.

Figure 2: Connector T1c/T1cx at TMR location

2. If the contact at the vehicle side of the wiring harness (T1c) is oxidized it can be replaced with a repair cable. Refer to figure 6 or 7.

3. If the connector on the steering side of the harness (**T1cx**) is also affected, replace the steering harness section as well.

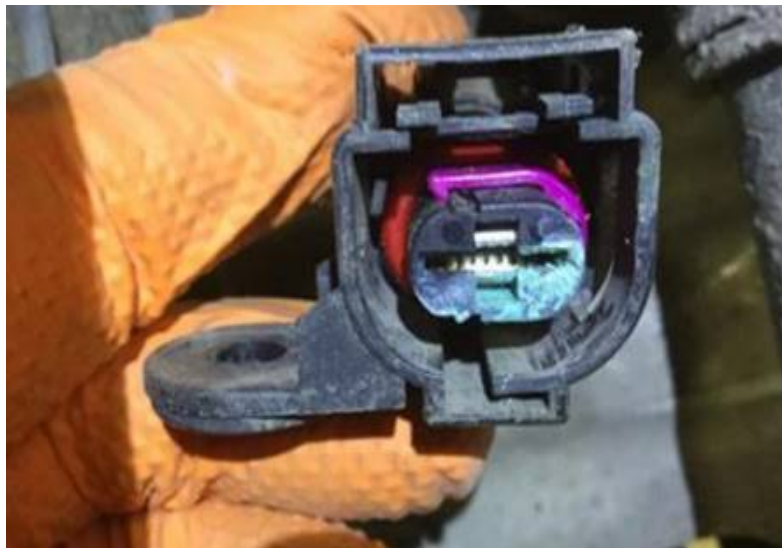
Figure 4: Oxidized connector at T1c

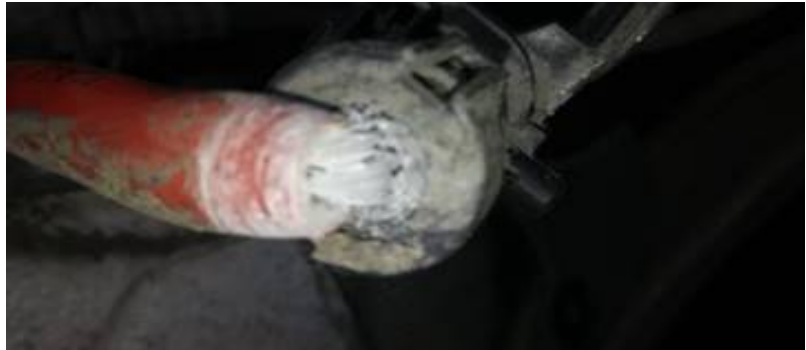
Figure 5: Oxidized wire at T1cx
