SERVICE BULLETIN

2017-22MY Impreza 2018-22MY Crosstrek 2019-22MY Forester 2019-22MY Ascent **NUMBER: 16-132-20R**

SUBJECT: Diagnostic Information for Alleged Chain Slip Condition

on TR580 / TR690 Transmissions

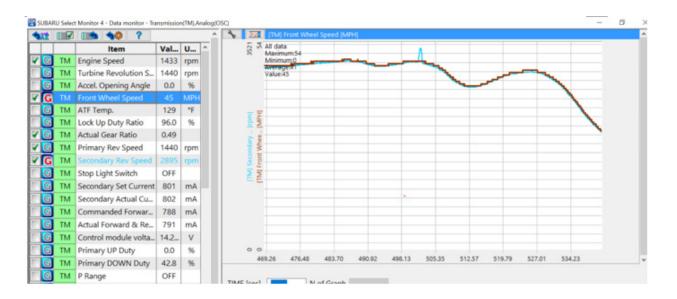
ront Wheel 20 Example screenshot of TCM PIDS with Front Wheel Speed and Secondary Revolution Speed selected.

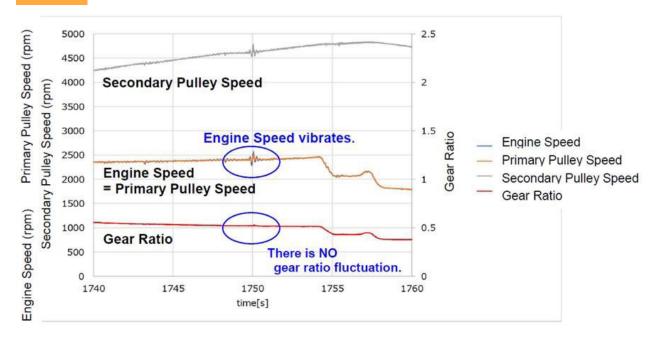
The graph above is an example of recorded SSM data showing the torque fluctuation is NOT being caused by the transmission but by torque fluctuation of the engine.
