Articles Contained in this Issue

CODE	ARTICLE.....	PAGE
(00)	STIS New Releases	10-11
(01)	QMR of the Month.....	1-2
(01)	QMR of the Month Award Presentations.....	2
(01)	The Winning Team of the 2021NTXAD Tech Competition!	3
(05)	TPMS Sensor Installation	4
(07)	Lane Keep Assist Inoperative, Even When Set To "ON"	5
(15)	2022 BRZ Auto-Dimming Homelink Mirror Inoperative.....	6
(15)	DTC P0116 Setting with Engine Block Heater Use.....	7

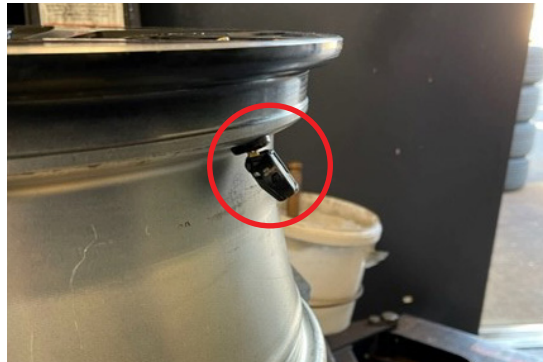
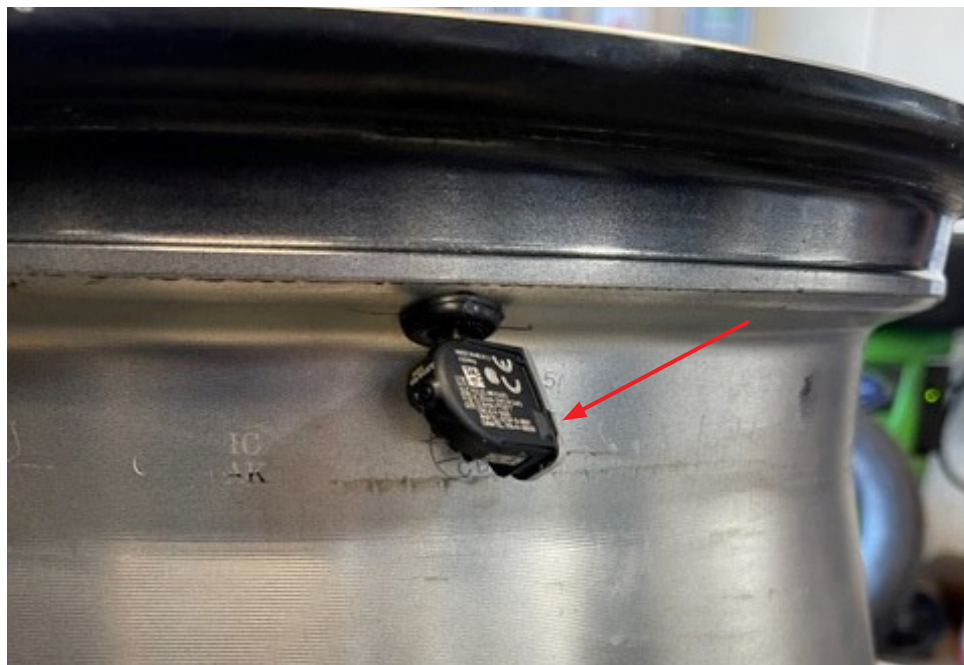
It has been brought to SOAs attention there is the possibility of installing newer style TPMS sensors incorrectly. If this happens, the sensor may not function as designed to read the rotational force during driving and wake up/communicate with the TPMS control module. This may result in intermittent DTCs and/or tire pressure values not displaying in the combination meter. When installing new sensors, it is imperative they are installed properly for the TPMS system to operate as intended. Refer to STIS for correct sensor orientation and installation procedures. Shown below is an incorrectly installed sensor for reference.

- (a) Wheel
- (b) Transmitter
- (c) Screw
- (d) Valve

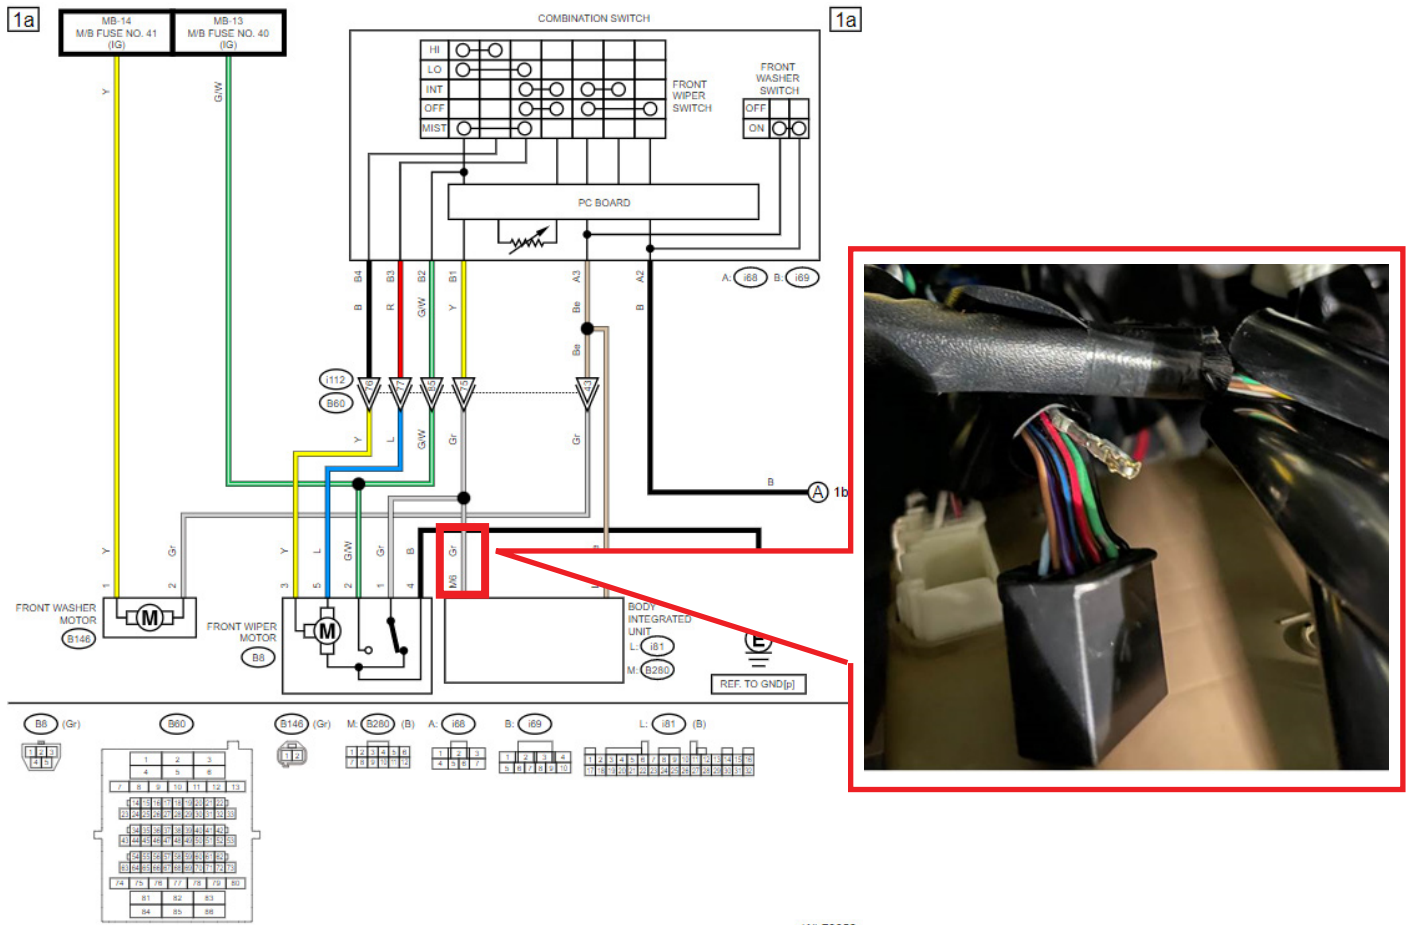
WI-78056

In the case of this, 19MY Ascent, the Automatic Adjustment and Function Check by Driving in the Camera Adjustment Inspection would not complete. The adjustment made no changes while being monitored in the live data. This was caused by an ‘open circuit’ between the Wiper Switch and BIU. The BIU was unable to distinguish between a ‘switch opened’ and ‘open circuit’, therefore communicating ‘Hi’ with the Eyesight system. When this is received by the Eyesight system, it is interpreted as the wipers being active and will not run the Auto Adjustment procedure. To confirm this, Technicians should look at the Eyesight live data PID, Wiper SW (Front). If the PID is found ‘ON’ continuously, without wiper activation, suspect the wiper switch circuit to be open or shorted.

For this 19MY Ascent, the circuit was open. Connector B280 at the BIU had a backed-out pin. Once properly seated in the connector, the system returned to normal operation.

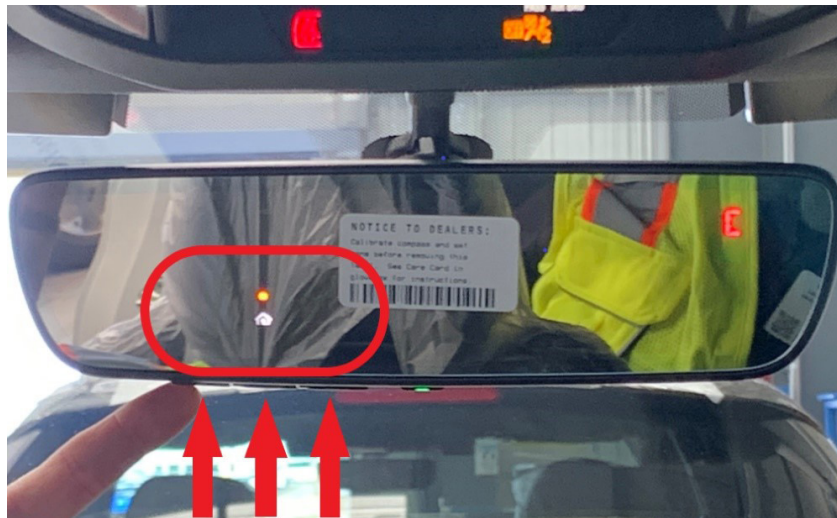
If a customer presents with a concern of the HomeLink feature being inoperative, the Technician should inspect the mirror harness prior to performing additional diagnostic procedures. When an incorrect harness is installed, the HomeLink icons will not illuminate properly when the corresponding buttons are pressed.

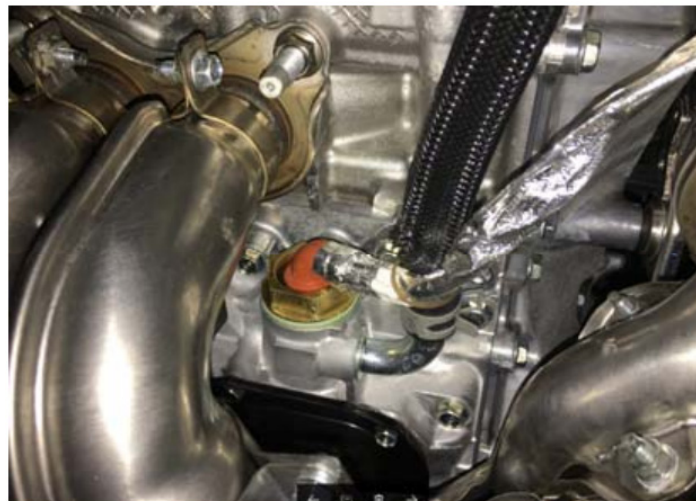
When encountering a vehicle with DTC P0116, first verify if an engine block heater is installed. If no engine block heater is installed, please follow the applicable service manual on STIS.

If P0116 is set when using an engine block heater, this may be due to ECM logic. On earlier models at engine startup, the ECM monitors the engine coolant temperature against ambient temperature. Later models monitor both coolant temperature sensors against the engine oil temperature. If a predetermined temperature difference between the sensor is observed, P0116 may result. Refer to STIS for the applicable detecting criteria.

The ECM is able to detect an engine block heater is in use **ONLY IF** the heater controls are in **ON/AUTO mode**. To help avoid this DTC, instruct the customer to have the **HVAC in the ON/AUTO** position at engine start-up. This will allow the warmed and cold coolant to combine and circulate, allowing the ECM to determine a block heater is in use, thus helping to mitigate the trigger of P0116.

Refer to TSB **11-201-21** for additional information on ECM reprogramming. Additional reprogramming PAK files for more models will be released in the near future to counteract this DTC.
