SERVICE BULLETIN

APPLICABILITY: 2017-18MY Forester 2.5L

NUMBER: 09-84-22

SUBJECT: Exhaust Pipe Front (EPF) Replacement

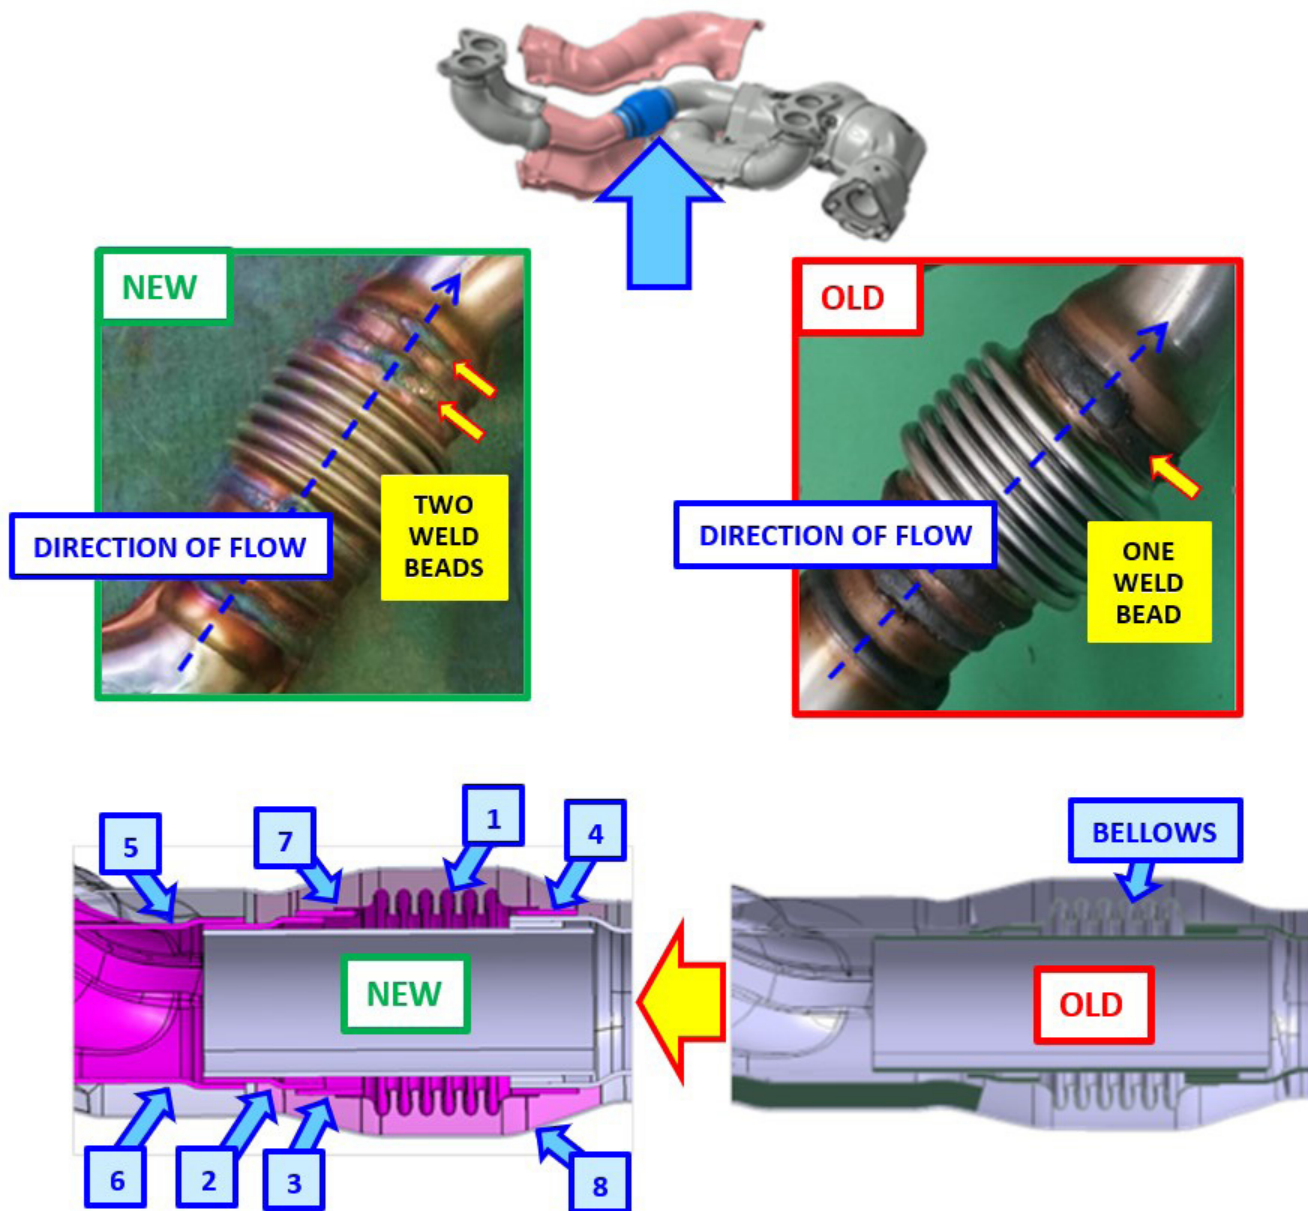
Description of Changes:

Part Description	Number	Areas of Change	Details
Front Exhaust Pipe (CONVERTER COMPLETE-FRONT)	1	Bellows	Material Change
	2	Holder	Re-Shaped
	3	Upstream Holder	Re-Sized
	4	Downstream Holder	Re-Sized
	5	Upper Elbow	Re-Shaped
	6	Lower Elbow	Re-Shaped
Upper Cover (COVER COMPLETE-CONVERTER PIPE FRONT)	7	Upper Cover	Re-Shaped (Described Next Page)
Lower Cover (COVER COMPLETE-CONVERTER PIPE FRONT)	8	Lower Cover	Re-Shaped (Described Next Page)
