## Insufficient Cooling Capacity and/or Compressor Noises

| Topic number | LI83.30-P-073900 |
| Function group | 83.30 - Air conditioning |
| Validity | 253 hybrids (code ME05 to ME10) |

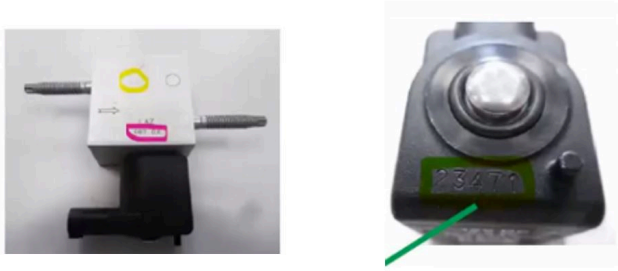
| Attachments | |
|---|--|
| <a href="#">Label Check vom Absperrventil Y19_3.JPG</a><br><br> | Instruction for taking pictures of shutoff valve Y19/3 |

(B.1) The low pressure goes toward  $\leq 2$ bar: Replace shutoff valve Y19/3 and take pictures of the valve as per the data sheet of the supplier (see attachment). Please create a PTSS case with all the information.
