# Customer Service Bulletin

## NiteHawk Raptor II Belt Tensioner Mount Replacement

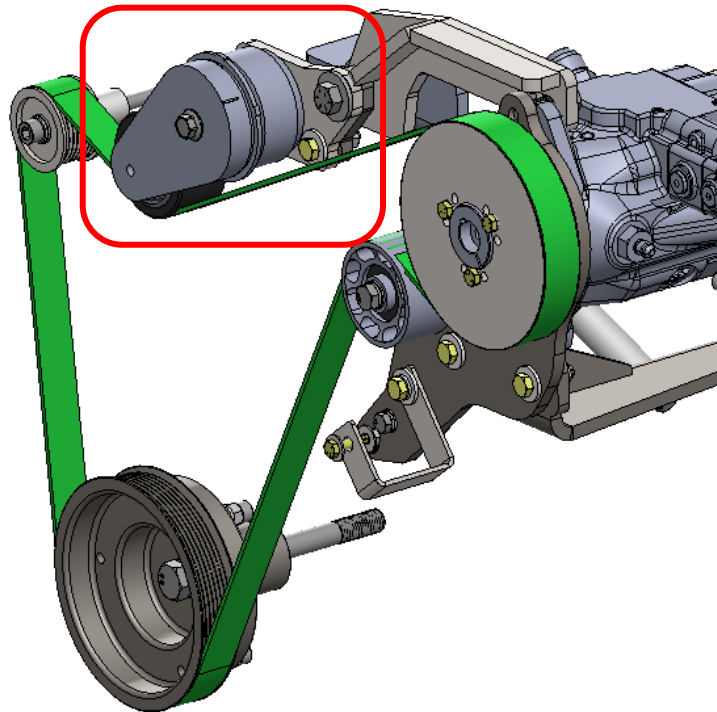
There have been several reports of customers experiencing problems with the pump belt tensioner (PM-1928) contacting the water pump on the truck's engine, rendering the truck temporarily undriveable. There is a replacement mounting bracket available from NiteHawk Sweepers that can immediately fix this issue. The steps for replacing the mounting bracket are outlined below.

Lift the cab of the Raptor II and locate the belt tensioner, indicated above. Remove the belt and set aside for reuse later.
