Y1A Taycan

On Board Charger (OBC) Fault P31D200 "Charging Socket – Overtemperature"

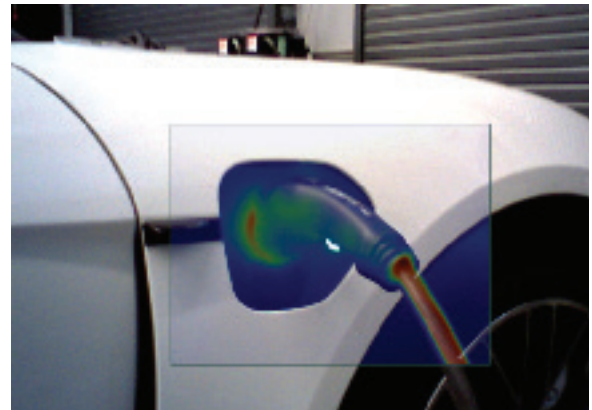
Figure 2

Pins and conductors within the vehicle cable charge handle reach high temperatures while charging for several hours on AC power. The charging socket temperature sensor in the vehicle charge port detects a high temperature and charging is stopped. This topic remains under investigation. This document will be updated with additional information when available.

Measure temperatures around the vehicle cable after at least 1 hour of full-power AC charging (208-240V, 40A setting). Check the temperature of the cable sheath below the vehicle connector, at the vehicle cable handle, and at the charge port of the vehicle. Compare the measured temperatures to another known-good charging cable used in similar conditions and with similar settings.
