Complaint: Insects in the Tail Light - Replacing and Reworking Tail Lights if Necessary (142/21)

Model Line: **Macan (95B)**

Model Year: **As of 2019**

Concerns: **Side tail lights (left and right)**

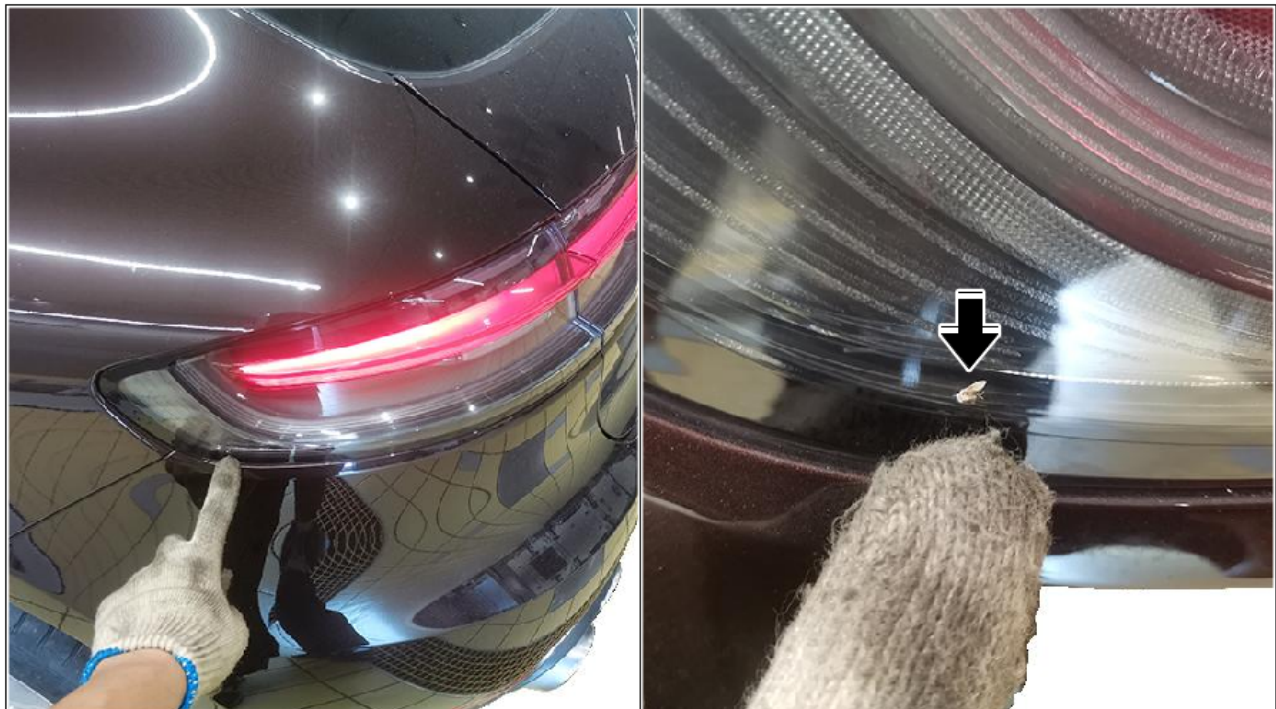
Information: The fact that the side tail lights open inwards for condensation reasons means that insects can get inside the tail light through certain openings in the body and tail light.

Insects getting into tail light

Action required: In the event of a customer complaint, replace the affected tail light and close off the opening for the cable bushing using a plastic foam strip.
