Taycan: Mechanical Noises from the Driver's Side of Dashboard

Vehicles Affected

Models	Model Year	Model Type	VIN Range	Vehicle-Specific Equipment
Taycan	2020 - 2021	Y1A/ Y1B	N/A	N/A

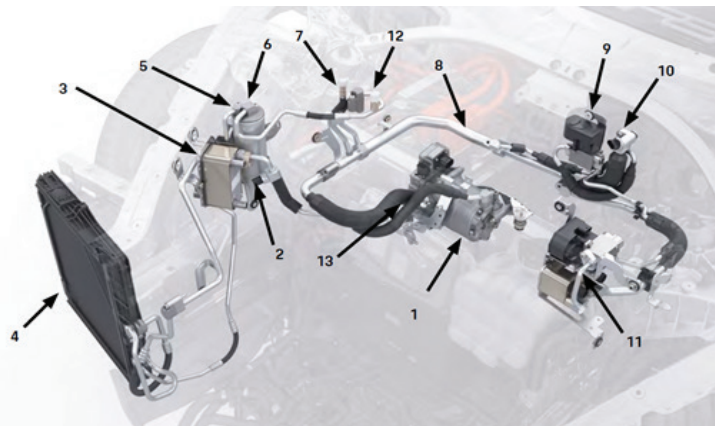
Figure 1: Refrigerant Circuit

The expansion valve contained in the evaporator in the air conditioning refrigerant circuit has hysteresis values stored in its internal memory from the supplier. After the thermal management control unit (TME) goes to sleep, these stored hysteresis values may be erased. The TME does not compensate for the erased hysteresis values. Therefore, when the valve's direction of movement is changed in a valve control activation which is less than a given hysteresis threshold, the worm gear clacks in the way a loaded spring would, and the position sensor on the gear drive can be indexed. The gear drive compensates for this behavior through cyclical motor control, resulting in the audible noise heard.

There is currently no permanent fix for this condition. Software changes for the TME that correct this condition have been made in production starting with model year 2022 vehicles. As of January 2022, this software is expected to be available for earlier model year vehicles in the second half of 2022.

In critical cases, please replace the expansion valve, part no. **9A781668200**, per Workshop Manual WM 877019 *Removing and installing expansion valve 1*.
