Subject: Exhaust Pipe and Cab Support Bracket Interference

Models Affected: Specific Freightliner New Cascadia vehicles built from April 20, 2021 through August 11, 2021.

CAL FTL 49-004

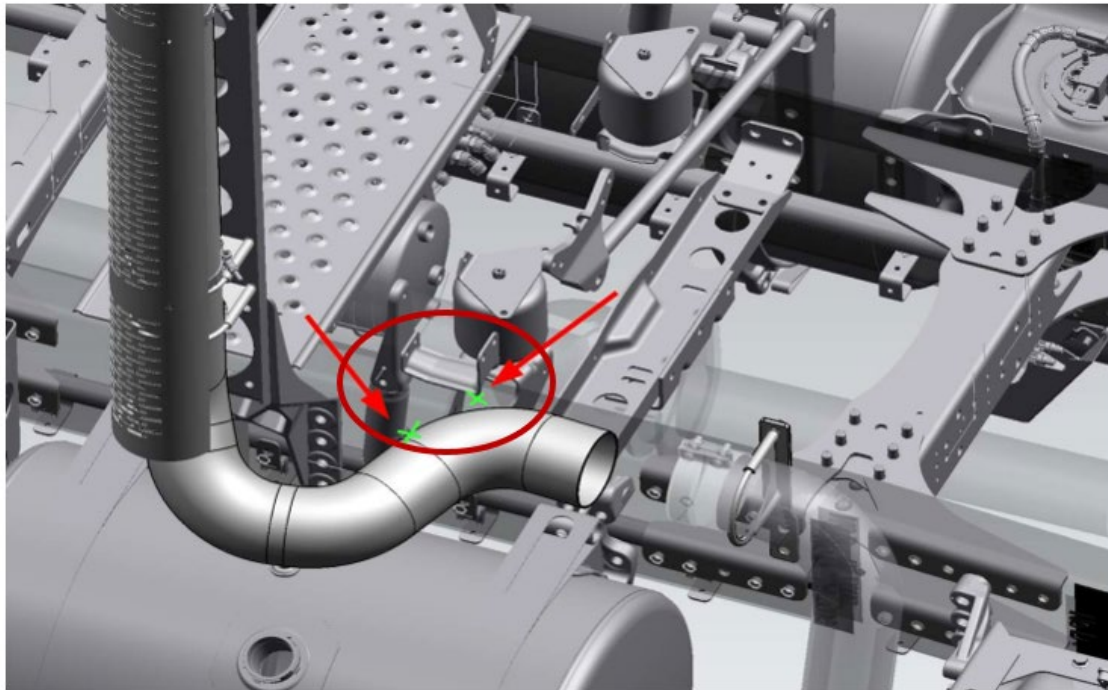
Eleven New Cascadia vehicles are reporting interference between the exhaust pipe and the lower cab mounting bracket. This CAL contains work instructions for fixing this issue.

Figure 6. Hard Interference points.

11. Inspect the area of the exhaust pipe called out in **Fig. 6** for any damage.

13. Inspect the section of the exhaust stack called out in **Fig. 6**.

13a. If the pipe is indented, replace this portion of exhaust pipe with the same part number, leaving the saddle clamps loose.

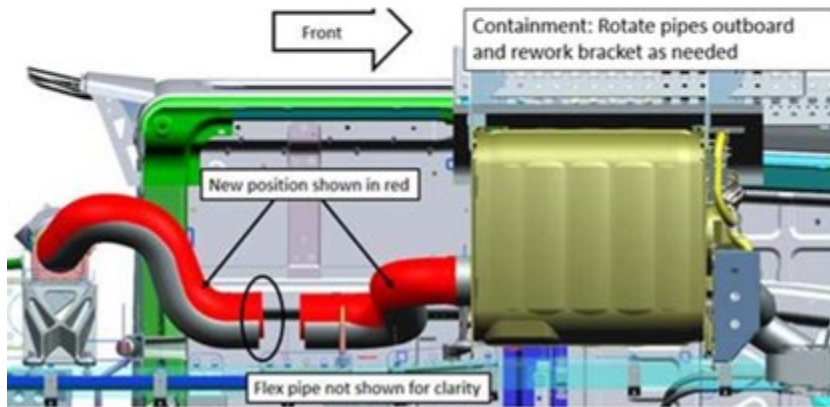
Containment shown on an effected vehicle

- Rotate pipes outboard
- Rework bracket
