## Mack Chassis - Equipped With Bendix Fusion, With Or Without Lane Departure Warning ( LDWS ) - Diagnostic Trouble Code ( DTC ) SPN 70 FMI 9, Bendix Code 64 With Possible "Lane Departure Warning Malfunction" Message - US17 And Newer

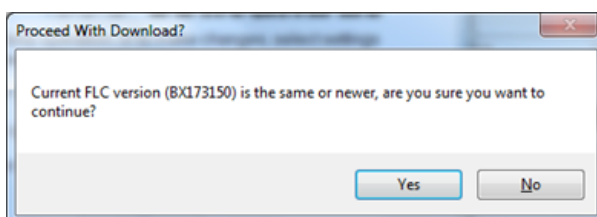
**NOTE:** If the error message shown below appears, the module software does not need to be updated.
