Constellation	4900
Heritage	> 5700
> 4700	5900
4800	6900

54-074

Pana-Pacific 540 Radio Controls Not Operating Normally

Western Star
Service Bulletin

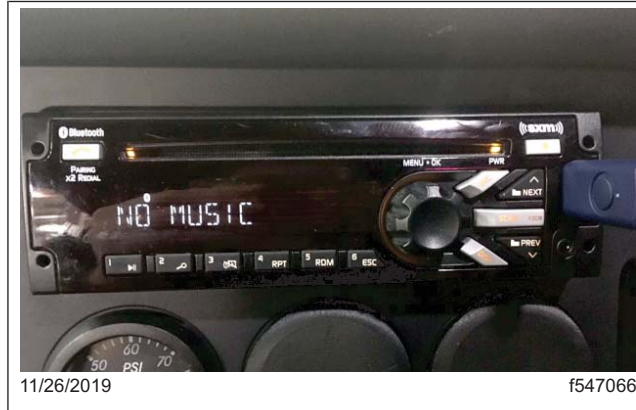
Fig. 1, Radio Displaying "No Music"

5. Plug in the USB stick to the radio. The radio will display "No Music." See [Fig. 1](#).

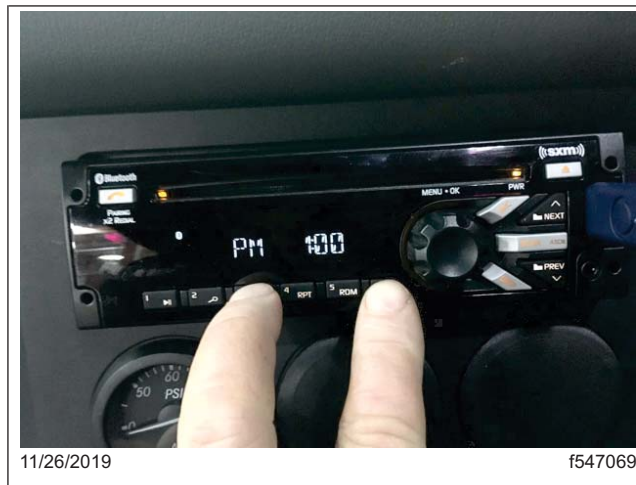
Fig. 2, Holding Buttons 3 and 6

6. Press and hold buttons 3 and 6 until the radio resets. See [Fig. 2](#). The radio will display "BOOTLOADER" and "REFLASHING" during the programming process. See [Fig. 3](#) and see [Fig. 4](#).

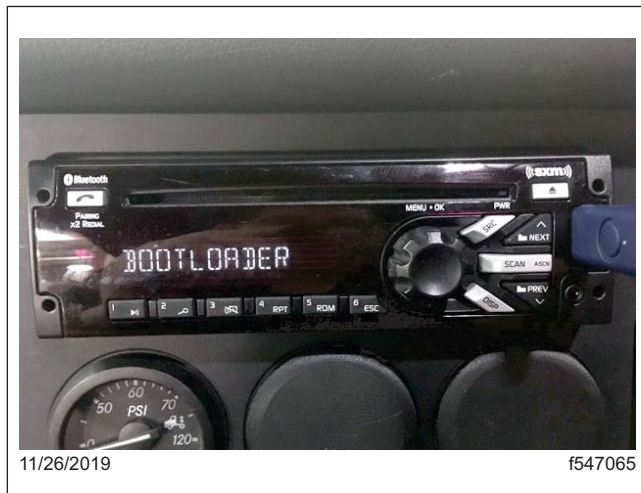
Fig. 3, Radio Displaying "Bootloader"

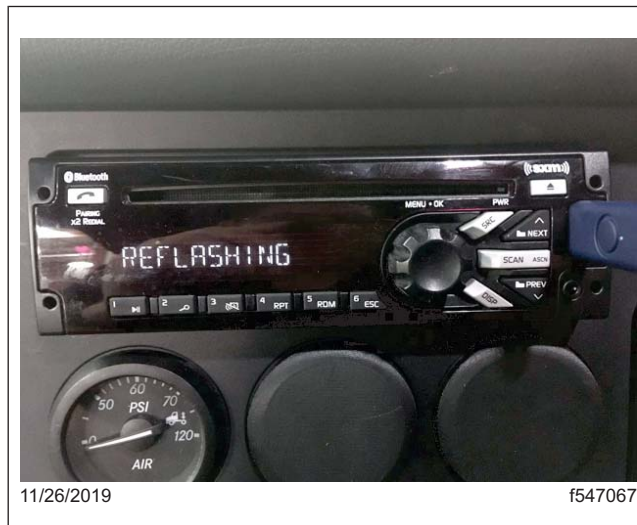
Fig. 4, Radio Displaying "Flashing"

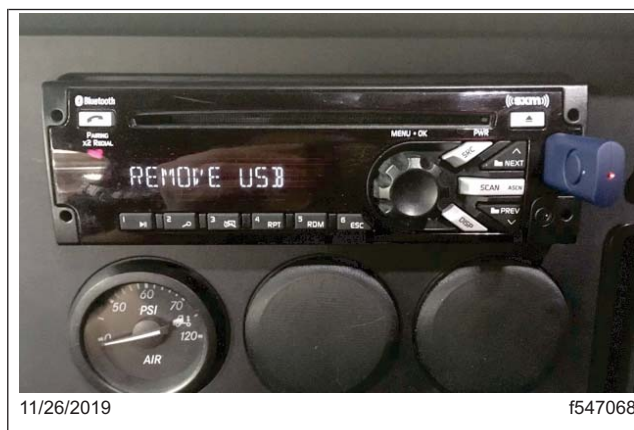
Fig. 5, Radio Displaying "Remove USB"

Wait for "Remove USB" to display. Remove the USB. See [Fig. 5](#).
