# McLAREN ELVA REAR WHEEL ARCH LINER REWORK

<b>Bulletin type:</b>	Service Campaign
<b>Campaign reference:</b>	SCB 26 A 010
<b>Attention:</b>	Retailer Aftersales Managers, Retailer Service Managers, Retailer Service Advisors, Retailer Technicians, Retailer Parts Managers
<b>Affected vehicles:</b>	McLaren Elva – specific VINs
<b>Situation:</b>	Rear Wheel Arch Liner requires trimming
<b>Procedure:</b>	Action affected vehicles during next Retailer visit. Please refer to the information outlined in this document to complete the checks required
<b>Date:</b>	20 <sup>th</sup> January 2022

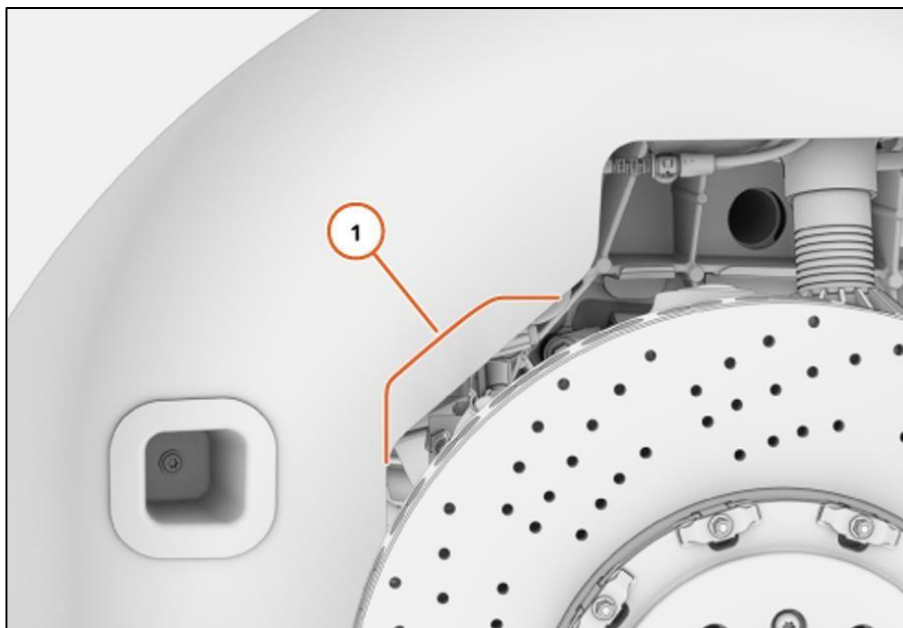
Through continuous product quality monitoring, McLaren Automotive has identified that on a number of McLaren Elva vehicles the inboard edge of the rear wheel arch liner is in close proximity to the rear brake pad sensor wiring, wheel speed sensor wiring and brake hose. Under rear suspension bump condition, the wiring and/or the brake hose may clash with the rear wheel arch liner. Therefore, a rear wheel arch liner rework procedure has been released.

Image 1 – Rework area of the rear wheel arch liner

The rework procedure involves trimming of the carbon fibre rear wheel arch liner therefore a suitable workshop tool must be used for the process.

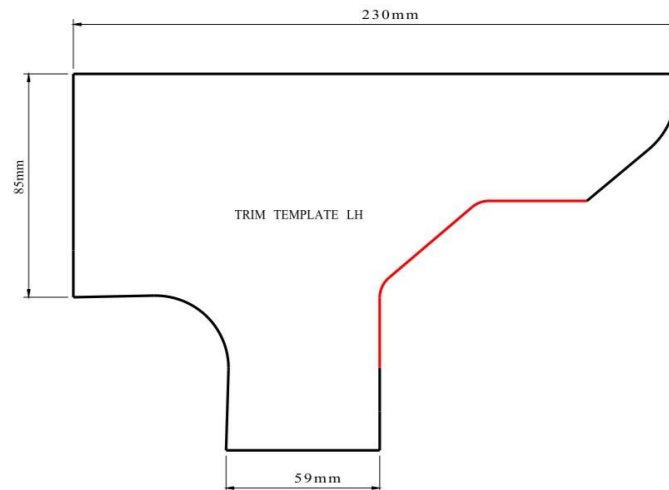
Image 2 - Example (not in scale) of the printable template and its reference dimensions (mm)

To aid the accuracy of the trimming rework, a printable pdf template file has also been attached to this Bulletin. Before commencing the rework, please print the template on A4 paper. To preserve the dimensional accuracy of the printouts, ensure the “actual size” or “100% zoom” settings are selected in your printer equipment. Use a ruler to measure the printed template lines to ensure their lengths measure exactly as per the reference dimensions shown on the template itself in millimetres (mm).

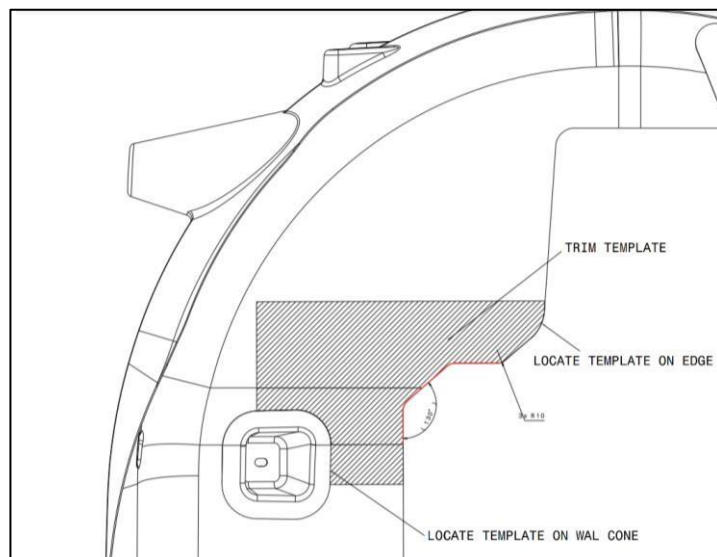
Image 3 - Positioning of the template on the wheel arch liner
