TECHNICAL TOPICS

Massage Seat PIVI Screen Button – Greyed Out

2021-2022 Discovery

Land Rover SSM75643 has been published for this concern

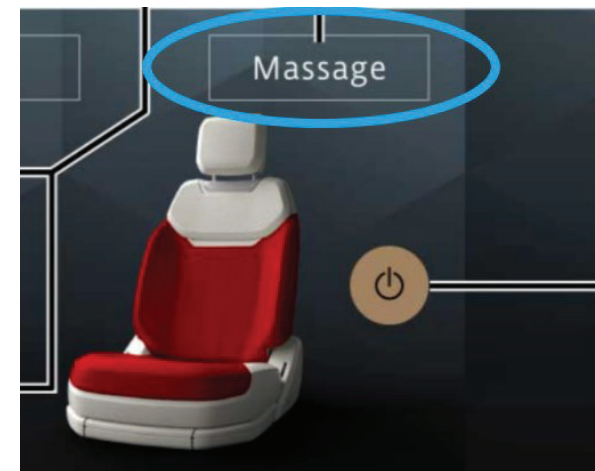
- JLR is investigating front passenger seat button becoming greyed out in certain seating positions, disabling the feature for the customer.
- This will affect the front passenger seat only.
- The error state is driven by the seat squab angle in certain inclined positions.

- PIVI OS 3.0.0 update has introduced an issue where the system disables the Massage Seat feature, due to thinking the customer is not using the seat.

- A software update is being progressed to resolve this concern

The following workaround is available in the interim

- Recline seat squab angle sufficiently to bring the button to available (Not greyed out on the screen) or the button reappears while the seat is moving through another axis.
- Massage works OK once in a position that the button appears
