TECHNICAL TOPICS

Water Ingress Into Passenger Compartment

20 - 22MY Defender

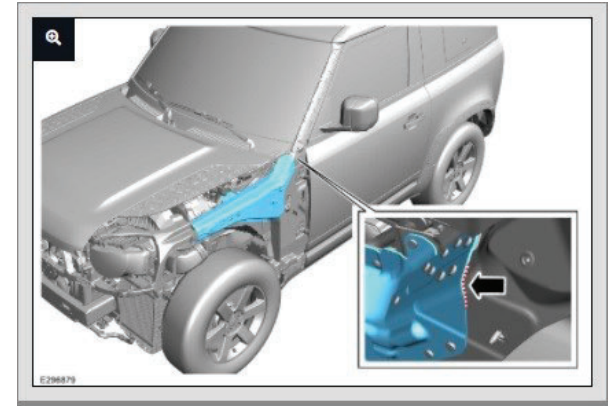
- A customer may report water ingress into the floor carpet.

- This may be caused by improper sealing of the lower A-Pillar body seam. This can cause water to enter the vehicle cabin behind the floor carpet. This can also lead to water leaking down the vehicle wiring harness and into the transmission wiring connector (C31D1/2) and causing a battery draw and cooling fan to run continuously with the vehicle turned off.

- The procedure to diagnose and repair this water leak concern has been published in the Workshop Manual Section 501-25C: Body Repairs – Water Leaks > Diagnosis and Testing > Water Leak Diagnostics.
