# RCA-78-22-001-1: Rear Wheel Speed Sensor Harness Seating

<b>Document Type</b>	Customer Satisfaction Campaign Bulletin
<b>Date</b>	January 13, 2022
<b>Affected Region(s)</b>	USA
<b>Affected Model(s)</b>	R1T
<b>Model Year(s)</b>	2022
<b>Approximate Build Dates</b> Refer to the FSA Dashboard to determine if this document applies to a specific vehicle.	August 2021 - September 2021
<b>Vehicle System</b>	78 - Low Voltage Electrical
<b>Minimum Service Location</b>	Mobile

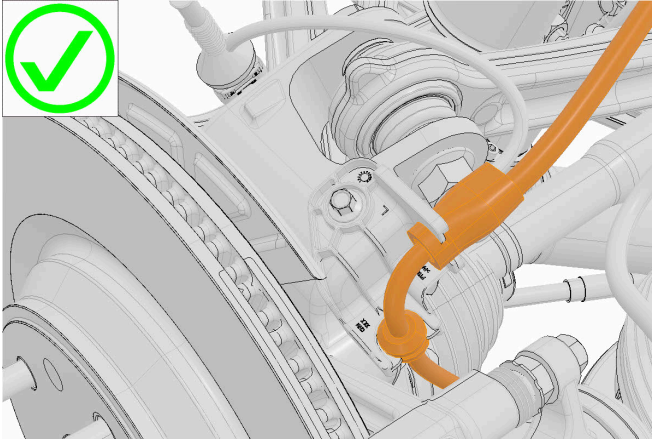
Check the component to see if it is properly seated.

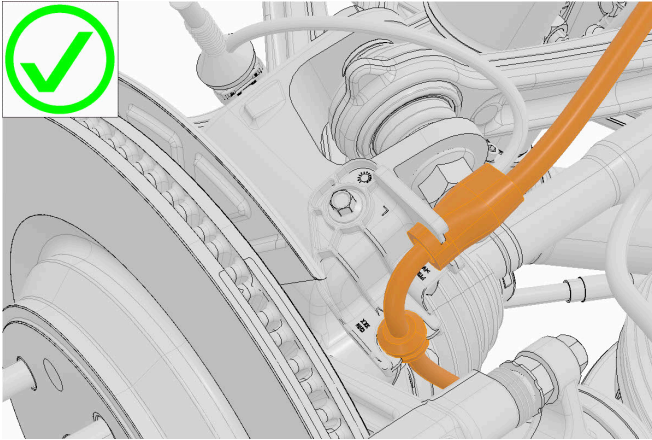
- If the component is properly seated, skip to the [Retainer Installation](#) section.
  - If the component is loose, continue to the next step.
3. Inspect the component for abrasion from contact with the wheel.
- If the component shows signs of abrasion, Replace: Harness, Wheel Liner, Rear (refer to service manual procedure 787066010).
  - If there are no signs of abrasion, continue to the next step.
4. Re-seat the component as shown.
