GLOBAL SAFETY FIELD INVESTIGATIONS  
DCS6047  
URGENT - DISTRIBUTE IMMEDIATELY

Subject: N212354510 - Service Update  
Driver Seat Memory Control Module Programming Incorrect

Models: 2022 Chevrolet Silverado 1500 LTD  
2022 GMC Sierra 1500 Limited  
2022 GMC Sierra 2500HD/3500HD

## N212354510 Driver Seat Memory Control Module Programming Incorrect

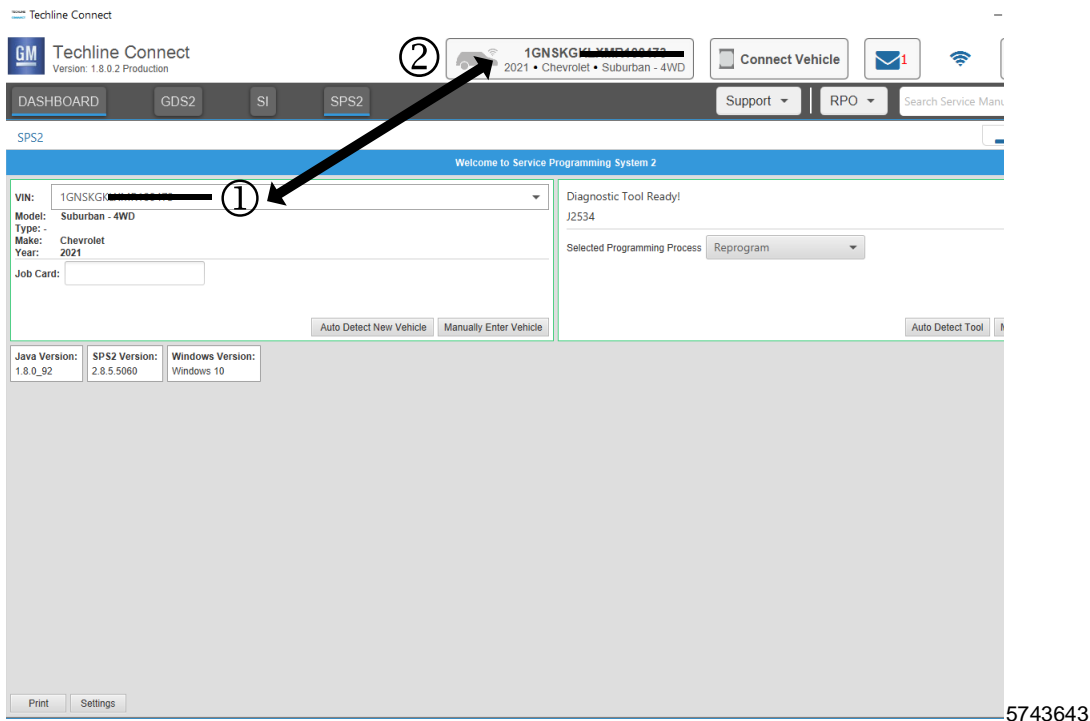
**Caution:** Be sure the VIN selected in the drop-down menu (1) is the same as the vehicle connected (2) before beginning programming.

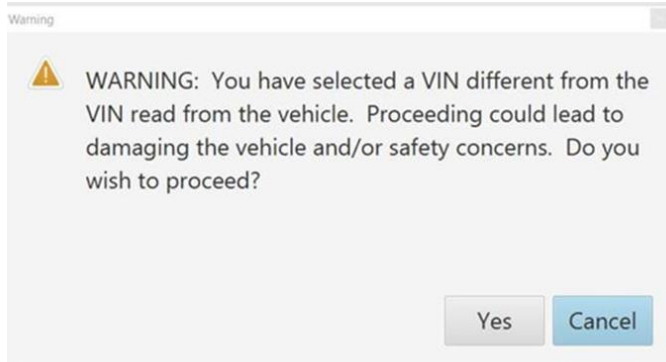
5877000

**Important:** If the vehicle VIN DOES NOT match, the message below will be shown.

**Important:** If the same calibration/software warning is noted on the TLC Summary screen, select OK and follow screen instructions. After a successful programming event, the WCC is located in the Service Programming System dialogue box of the SPS Summary screen. No further action is required. Refer to the Warranty section of the bulletin.

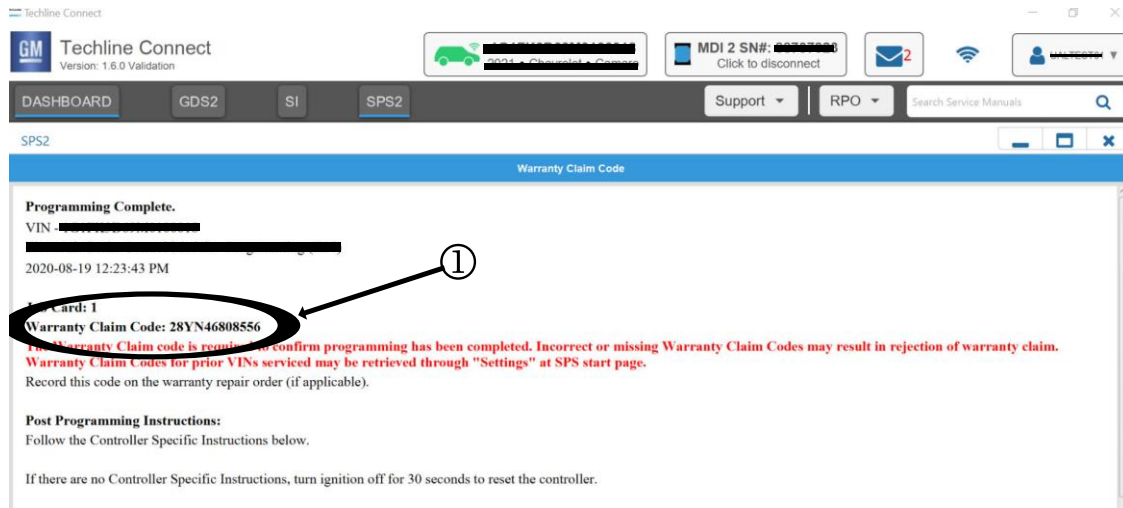
5644478

**Important:** To avoid warranty transaction rejections, you **MUST** record the warranty claim code provided on the Warranty Claim Code (WCC) screen shown above on the job card. Refer to callout 1 above for the location of the WCC on the screen.

2. Record SPS Warranty Claim Code on job card for warranty transaction submission.
