HYUNDAI Technical Service Bulletin	GROUP AUTOMATIC TRANSMISSION	NUMBER 22-AT-001H
	DATE JANUARY, 2022	MODEL PALISADE (LX2) SANTA FE (TMA) SANTA FE HYBRID (TM HEV) SONATA (DN8A) SONATA HYBRID (DN8 HEV) TUCSON (NX4/NX4A) TUCSON HYBRID (NX4 HEV)
SUBJECT: AUTOMATIC TRANSAXLE PUSH-BUTTON SHIFTER DIAGNOSIS

This TSB supersedes TSB 21-AT-009H to add Symptoms, DTC and add Steps 7~9.

DESCRIPTION: This TSB provides a procedure to diagnose the push button shifter operation. If you are servicing a vehicle with any symptoms or DTC listed below, follow the Service Procedure, Page 2.

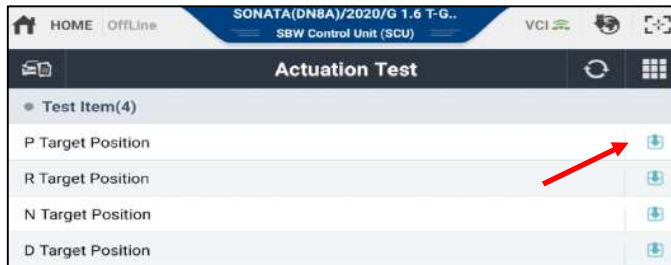
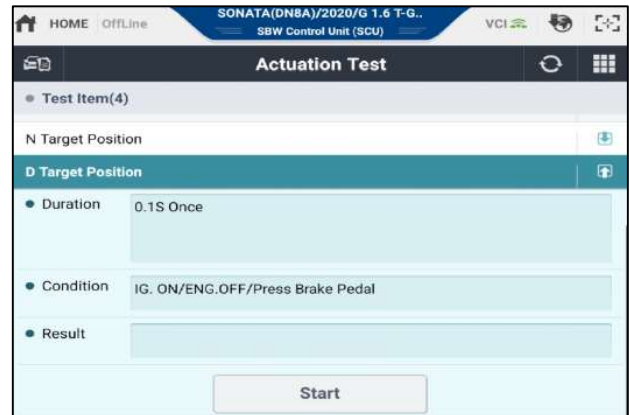
5. Turn the engine off and push the SSB 2 times to turn the ignition **ON**. Press the brake pedal. From the GDS home screen, select **Actuation Test** and **SCU** menu. Test the Target position for P, R, N and D. Press the arrow to change the selection. If the GDS and cluster show:
 - Correct **Target Position** for P, R, N and D: The SCU sent electrical current to the SBW actuator, the SCU and SBW actuator are currently operating correctly and the related harness currently does not have an open/short circuit. Go to Step 6.
 - Does not show the correct **Target Position** for P, R, N and D: The SCU, SBW actuator or related harness may have a fault.

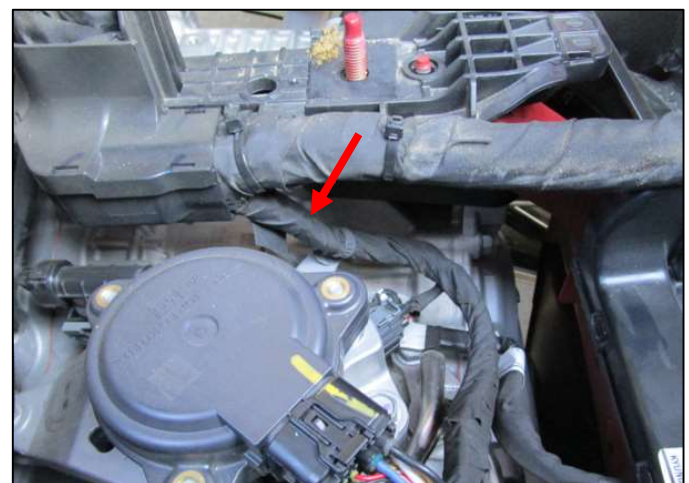
9. Record the customers radio presets.
Remove the air cleaner, battery and battery tray.
Check if the harness is in contact with the battery tray. If so, go to Step 10.

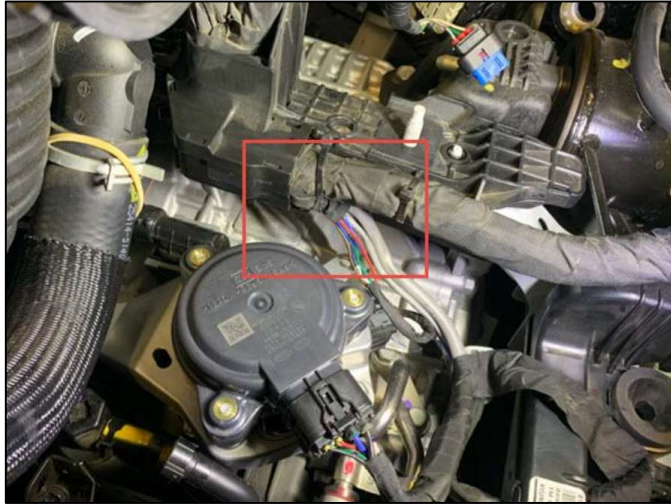
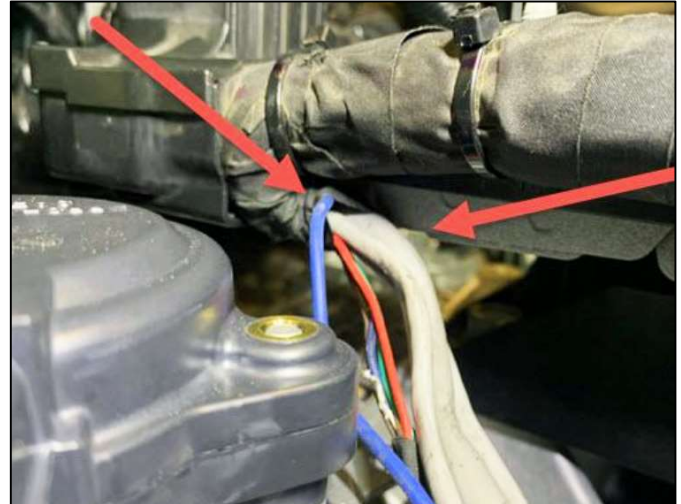
- If the harness to the SBW actuator is in contact with the battery tray, carefully unwrap the harness protector in the area shown below. Check the insulation on the wires to see if the insulation has been damaged by contact with the battery tray. If so, repair or replace the control harness.
