SERVICE BULLETIN

Classification: DA19-011C	Reference: NTB19-042C	Date: January 26, 2022
------------------------------	--------------------------	---------------------------

AEB WARNING LIGHT BLINKING

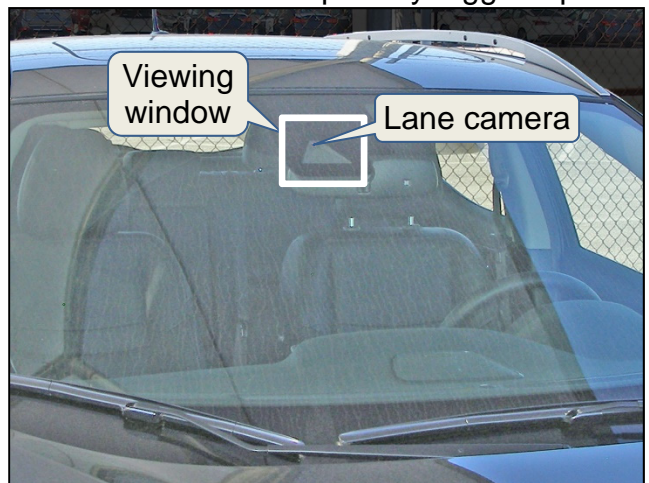
Figure 1

APPLIED SYSTEMS: Vehicles equipped with a lane camera (see Figure 1)

- When contamination or foreign material adhere to the lane camera viewing window on the windshield
- When driving while it is snowing or when frost forms on the lane camera viewing window on the windshield
- When the lane camera viewing window on the windshield is temporarily fogged up

is blinking (but not illuminated steadily) or the customer states it is blinking, and there are no related DTCs, inspect the windshield.

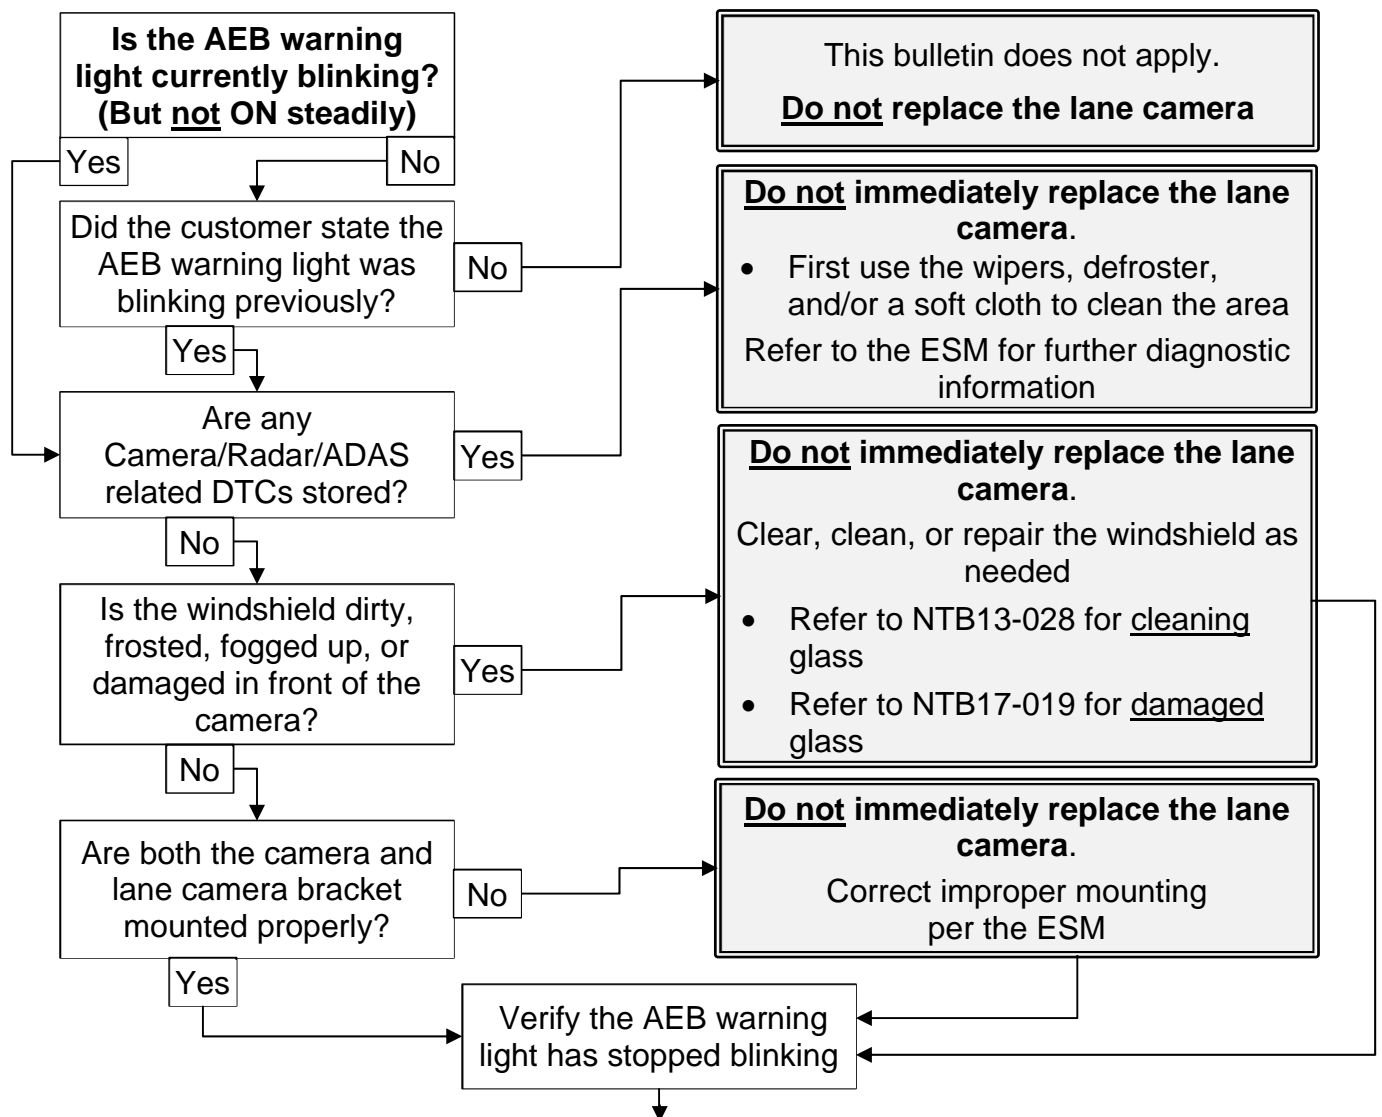
FLOW CHART

A blinking AEB warning light may occur under the following conditions:

Inform the customer the following conditions may cause the AEB warning light to blink:

- Heavy rain or thick fog may cause the light to blink as well. Good use of wipers and keeping the windscreen clean will mitigate some of the issue.
- When contamination or foreign material adhere to the lane camera viewing window on the windshield.
- When driving while it is snowing or when frost forms on the lane camera viewing window on the windshield.
- When the lane camera viewing window on the windshield is temporarily fogged up

Explain to the customer the difference between contamination detection and a malfunction.

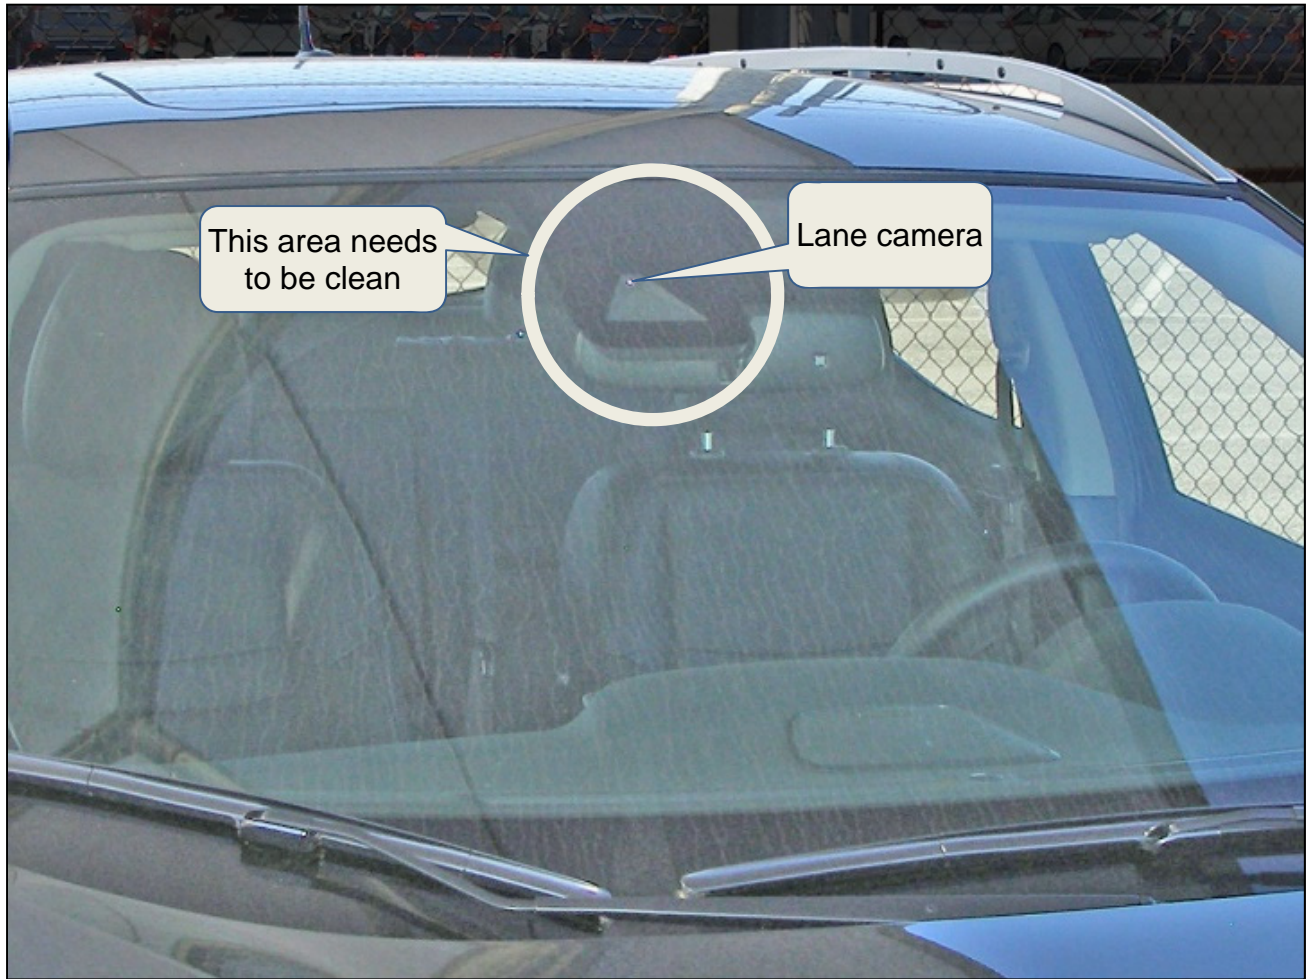
Figure 2

During the following conditions the AEB warning light may blink/flash. However when these conditions no longer exist, the AEB will resume automatically:

- Strong light is shining from over the front of the vehicle.
- The cabin temperature is over approximately 104°F (40°C) in direct sunlight.
- The radar sensor picks up interference from another radar source.
- When driving on roads without any road structures or buildings (for example: long bridges, deserts, snow fields, driving next to long walls.
