SERVICE BULLETIN

Classification: EC21-023	Reference: NTB22-001	Date: January 12, 2022
-----------------------------	-------------------------	---------------------------

DTC P0300 AND/OR P0301(2/3/4/5/6) IS STORED DURING A COLD START

APPLIED VEHICLES: 2022 Frontier (D41)

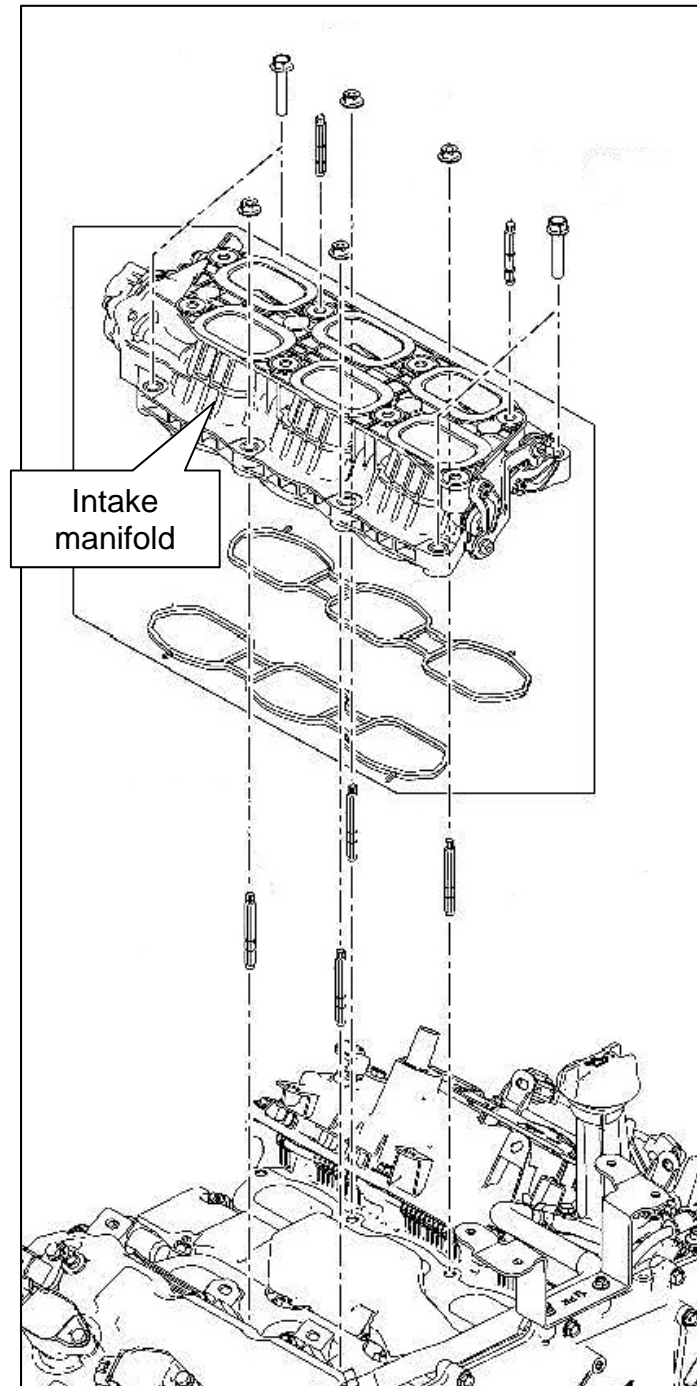
Figure 1

The DTC only stores during a cold start.

4. Replace the intake manifold (Figure 1) with one listed in the **PARTS INFORMATION** on page 4.
 - Refer to the ESM: **ENGINE > ENGINE MECHANICAL > VQ38DD > REMOVAL AND INSTALLATION > INTAKE MANIFOLD**
