Instrument Panel Trim Reflection

Service Category Vehicle Interior

| YEAR(S) | MODEL(S) | ADDITIONAL INFORMATION |
|---|---|---|
| 2018 - 2022 | Camry, Camry HV | |

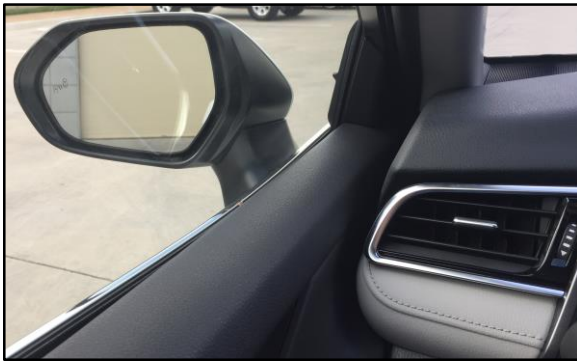
**Figure 1. Brushed Aluminum Trim
(Condition Example)**

Some 2018 – 2022 model year Camry and Camry Hybrid vehicles with brushed aluminum or gray metallic trim may exhibit a condition where the instrument panel left-hand and right-hand outside register assemblies reflect on a front side window glass.

Figures 1 and 2 are examples of this condition. Alternative outside register assemblies with a gloss black finish have been developed to reduce this condition, as shown in Figure 3. Follow the Repair Procedure in this bulletin to reduce this condition.
