Preliminary Information

PIT5839C Radio System Settings Lost or Returning to Default Values

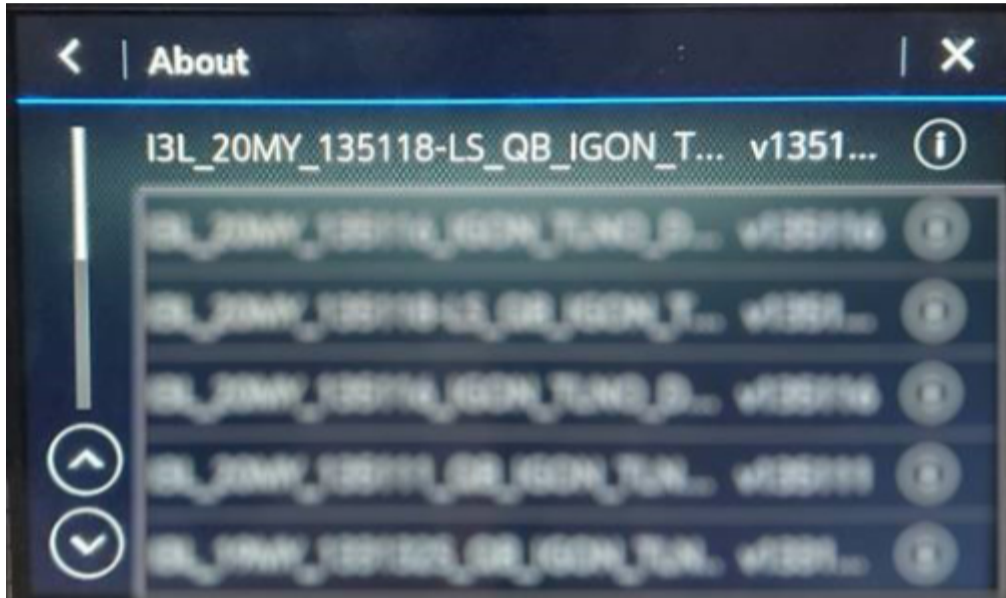
1. Verify the radio software version as this issue only pertains to version V135118. On the radio display, select Home, Settings, About. On this page will be what appears like a long file name. In the middle of this file name will be 135118.

- If the version is V135118 proceed to Step 2.
- If the version is numerically less than V135118 then this PI does not apply. Refer to SI for diagnostics.
- Tip: Before resetting the radio, please record the customer's stored Favorites so that they can be re-entered afterward. Once selected it is important to wait for the radio to complete this process and reboot itself before the ignition is turned off.
