Bulletin No.: PIP5345A
Published date: 01/6/2022

PIP5345A Unable To Achieve Preload On Pinion Bearings 9.5/9.76 Inch Rear Axles

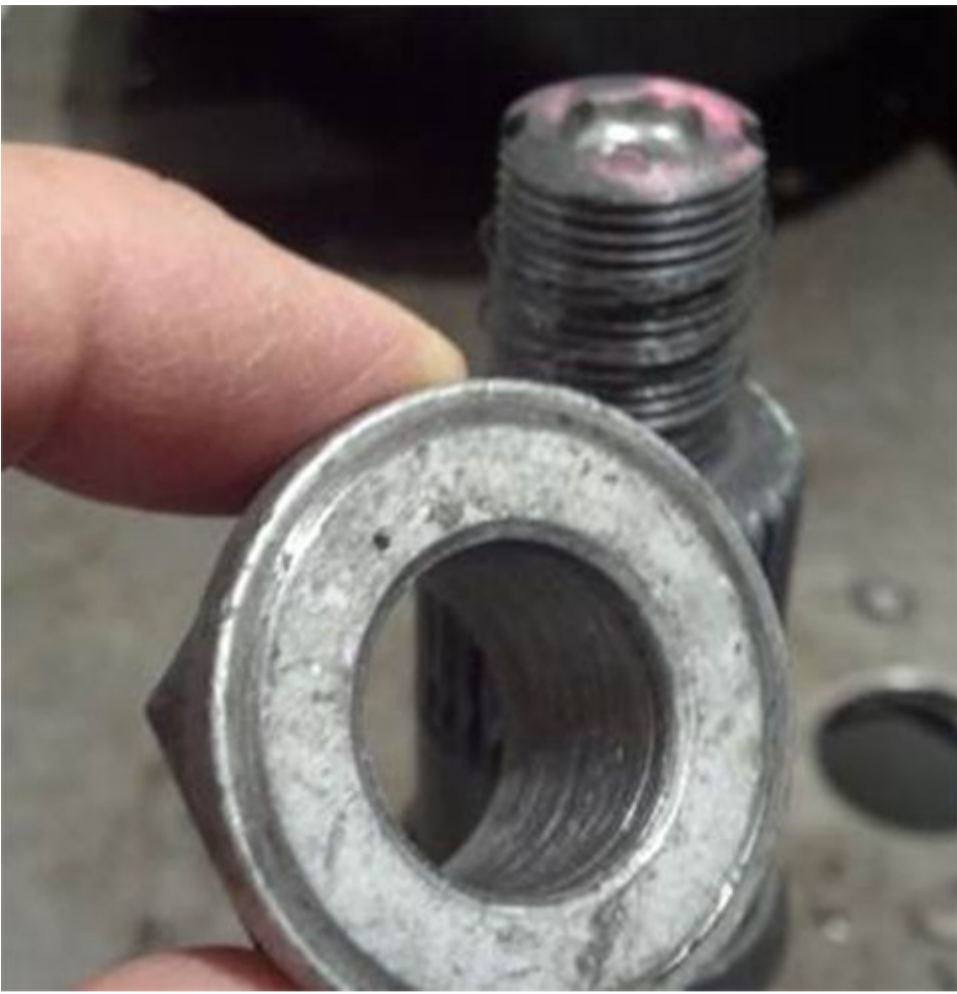
Technicians may be unable to achieve pre-load when setting up the pinion bearing pre-loads during reassembly of the 9.5/9.76 inch rear axles. Reports from the field include breaking of sockets, breaker bars, ratchets and pinion holding tool without achieving preload. Also we have seen pinion gears with stripped threads.

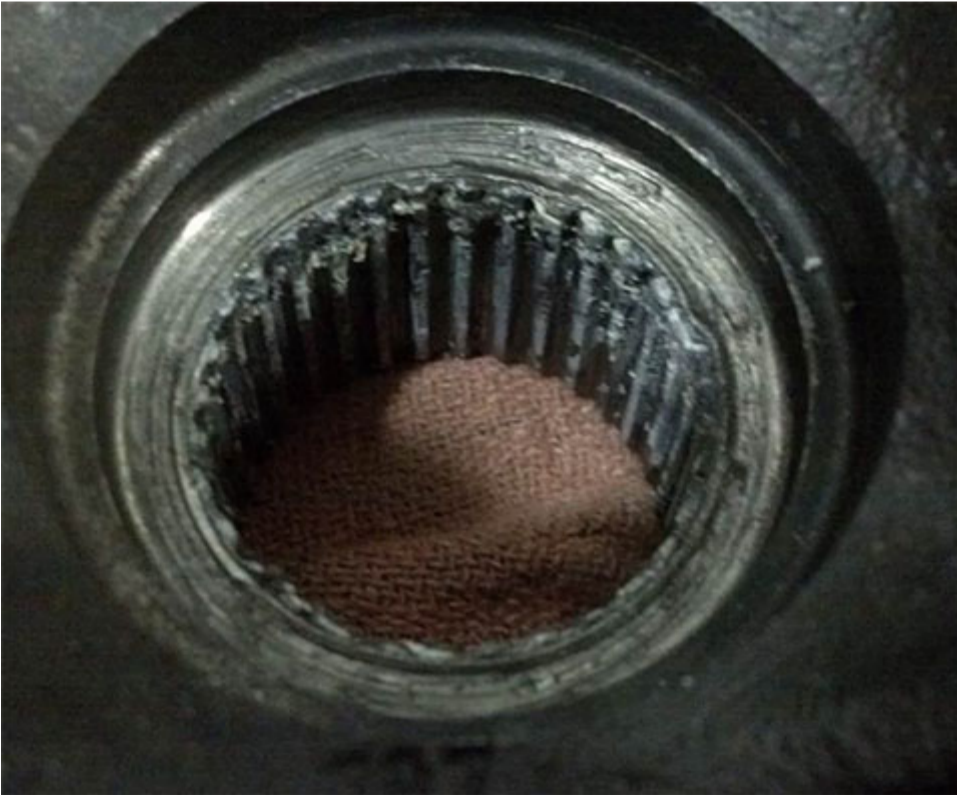
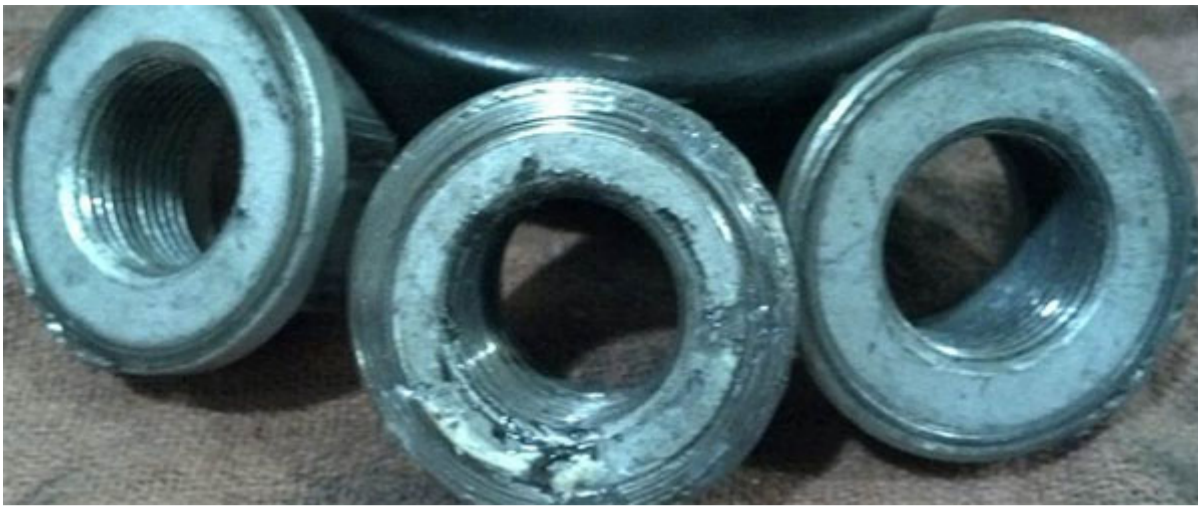
This has been identified to be caused when reusing a pinion flange that has imperfections in the mating surface where the nut contacts the flange. In rare occasions it has also been experienced with a new flange as the nut and flange mating surface start to wear into each other with high pressure associated with drawing the bearing and flange onto the gear. When there is extremely high amounts of torque applied to the pinion nut it is possible to deform the nut which starts the thread damage.

To aid in assembly the following information can be used in conjunction with Differential Drive Pinion Gear Bearing Replacement procedure in service information. With the pinion flange started onto the pinion gear install washer part number 11609638 onto the pinion shaft between the flange and nut.

Tighten the pinion nut until you achieve 10 lb in. (1.0 Nm) rotating torque.

Back the nut off and remove the washer.

NOTE: 9.5/9.67 in rear axles DO NOT USE a washer between the pinion flange and nut and the washer CANNOT be left in place.

Tighten the nut back down until you achieve 15 lb in. (1.7 Nm) for used bearings or 20 lb in (2.25 Nm) for new bearings.
