Bulletin No.: PIP5810

PIP5810 Transfer Case Input Seal Installation

Brand:	Model:	Model Years:	VIN:		Engine:	Transmissions:
			from	to		
Chevrolet	Silverado 2500 HD/3500 HD	2020 - 2021	All	All	All	MGM, MGU
GMC	Sierra 2500 HD/3500 HD	2020 - 2021	All	All	All	MGM, MGU

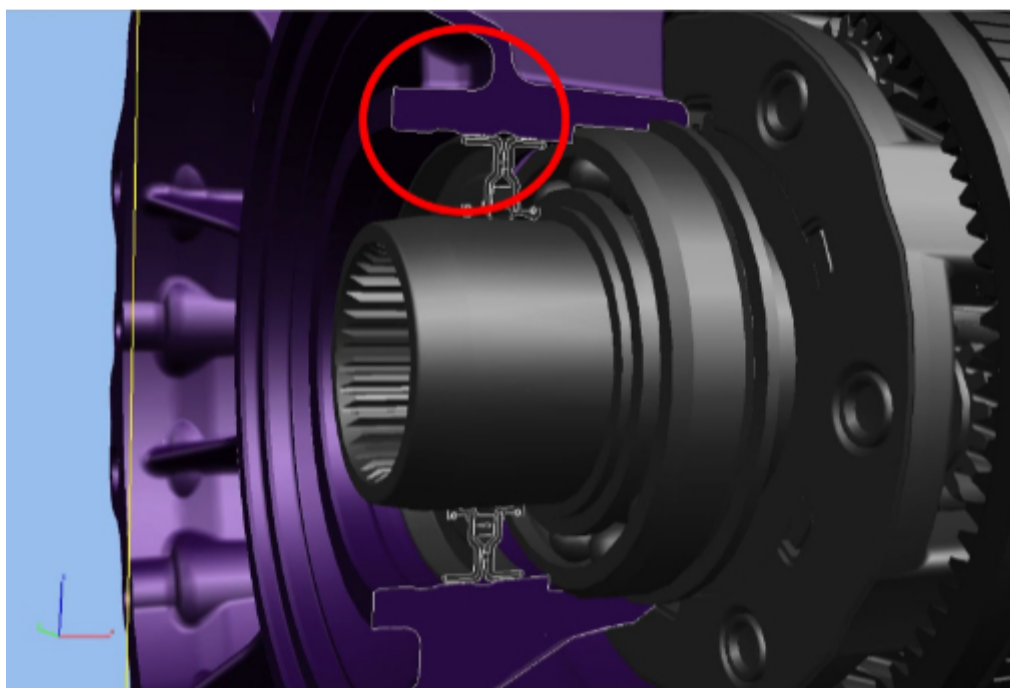
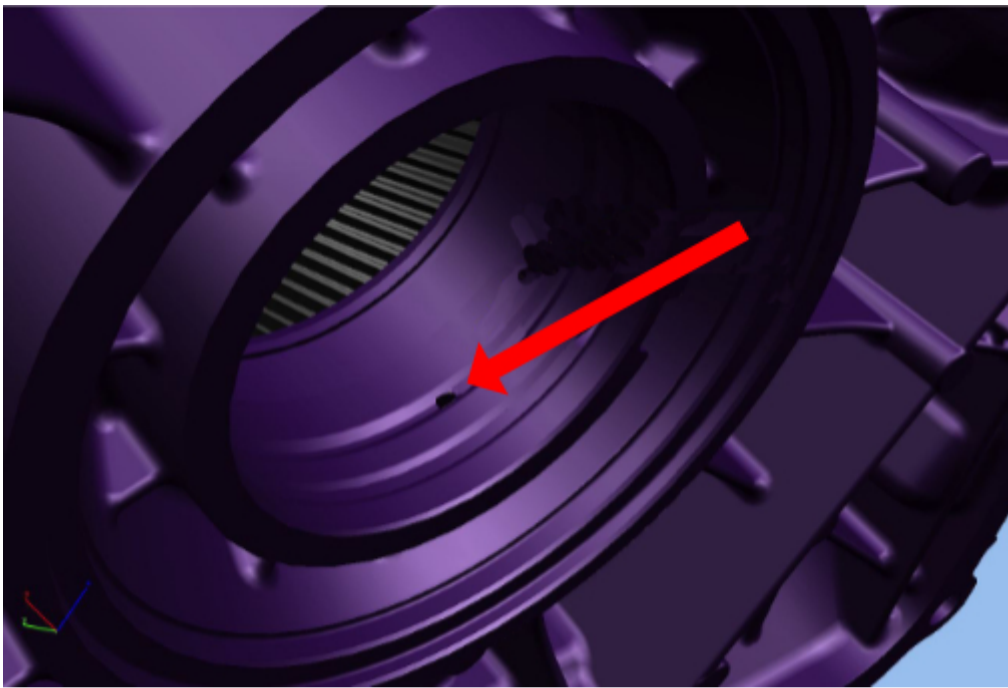
Seal installation depth is critical when replacing the transfer case input seal. There is a gap around the outer portion of the seal that needs to be centered over a weep hole in the case. Weep hole is drilled in the center of a groove machined into the case. Tool # DT-50648-A Seal Installer will not work for these applications.

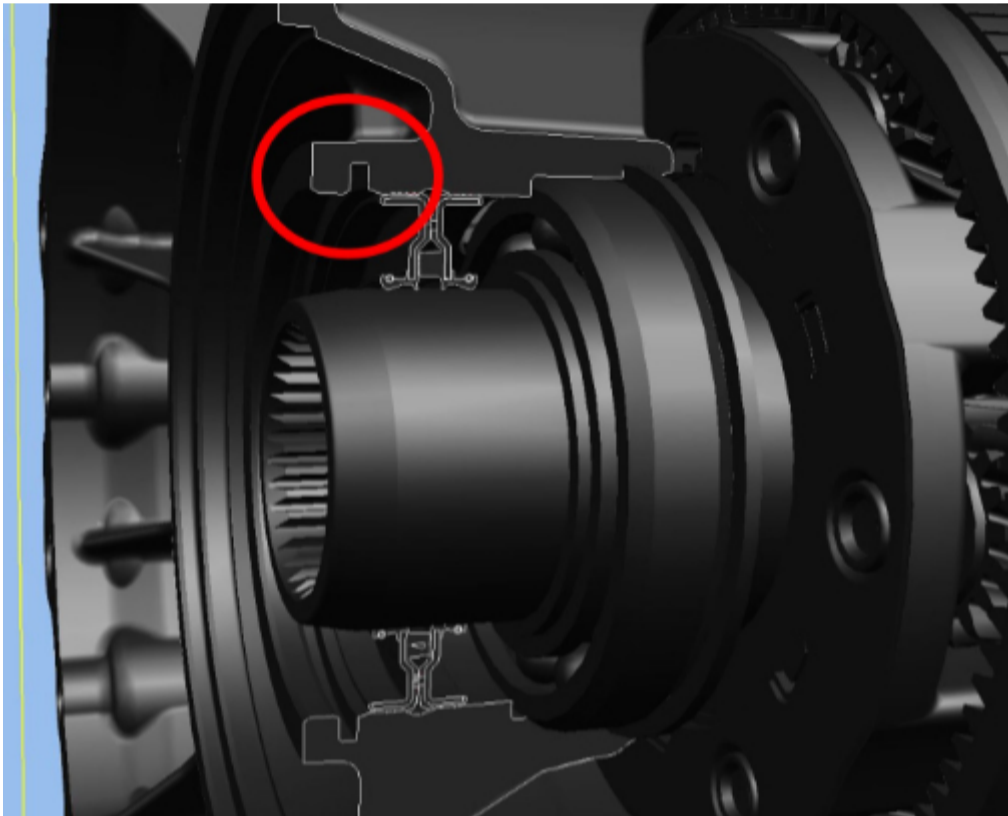
First Design

There are 2 design transfer case front case halves and the seals install at different depths between design 1 and 2. To identify design level look for a machined groove where the seal is installed (Red circles below). If there is a defined machined groove in the case then it is a first design case. If there is not a defined groove machined into the case then it is second design.
