PIT5386G Back Up Alarm Inoperative and needs to be Connected During PDI

Product Investigation Review Required

Equipped with Back Up Alarm (RPO 8S3)

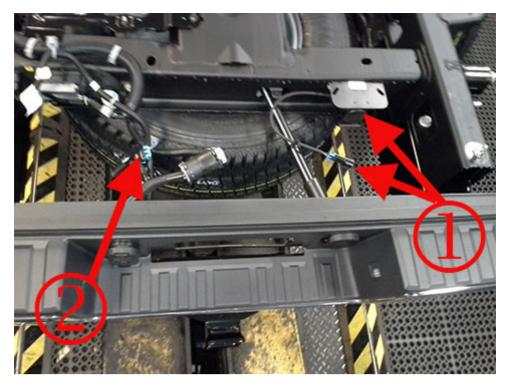
During the PDI it may be noticed that the backup alarm is inoperative. Trucks equipped with the Back Up Alarm (RPO 8S3), the alarm will be intentionally left disconnected from the assembly plant.

- 1. Back Up Alarm/Connector
- 2. Chassis Harness Alarm Connector

- For 2020-2022 3500 Chassis Cab models (31003, 31043, and 31403) the back up alarm is not installed on the truck's frame and it has been left loose inside the cab from the assembly plant. It is the upfitters responsibility to mount the back up alarm and splice into the reverse circuit. The labor op listed below does not apply to these vehicles because no additional work is needed during PDI. Refer to the latest revision of UI Bulletin 175 (https://www.gmupfitter.com/technical-bulletins/) for more information
- For All Other Trucks, the alarm is located on the right rear of the frame, and the chassis harness alarm connector is located on the left rear of the frame. Route the harness up and over the spare tire hoist tube and connect to the backup alarm.
