Preliminary Information

PIT5340F Hood Shakes While Driving

Brand:	Model:	Model Years:	VIN:		Engine:	Transmissions:
			from	to		
Chevrolet	Colorado	2015 - 2022	All	All	All	All
GMC	Canyon	2015 - 2022	All	All	All	All

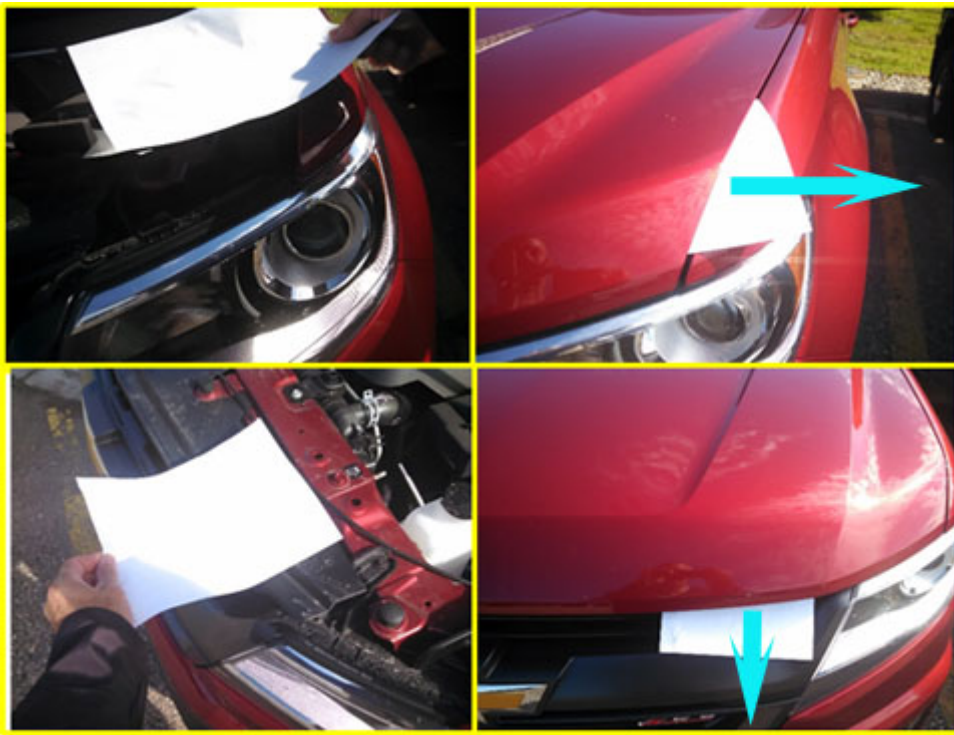
2. With a piece of paper, check all 6 bumpers with this paper test.

The 4 outboard bumpers must have good contact and the paper should not pull free when the hood is closed.

The 2 inboard bumpers must have slight clearance to the hood so the paper should pull out but with some drag.
