# Preliminary Information

## PIT5886 Tailgate Latch Handle Disengaged From Tailgate

| Brand: | Model: | Model Years: | VIN: | | Engine: | Transmissions: |
|---|---|---|---|---|---|---|
| Chevrolet | Silverado 1500 | 2019 - 2022 | All | All | All | All |
| GMC | Sierra 1500 | 2019 - 2022 | All | All | All | All |

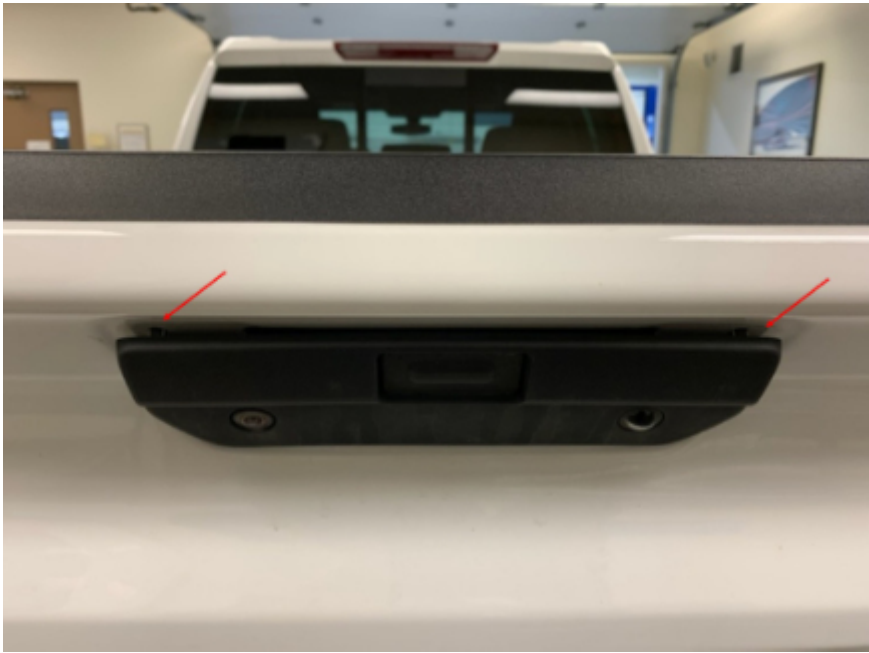
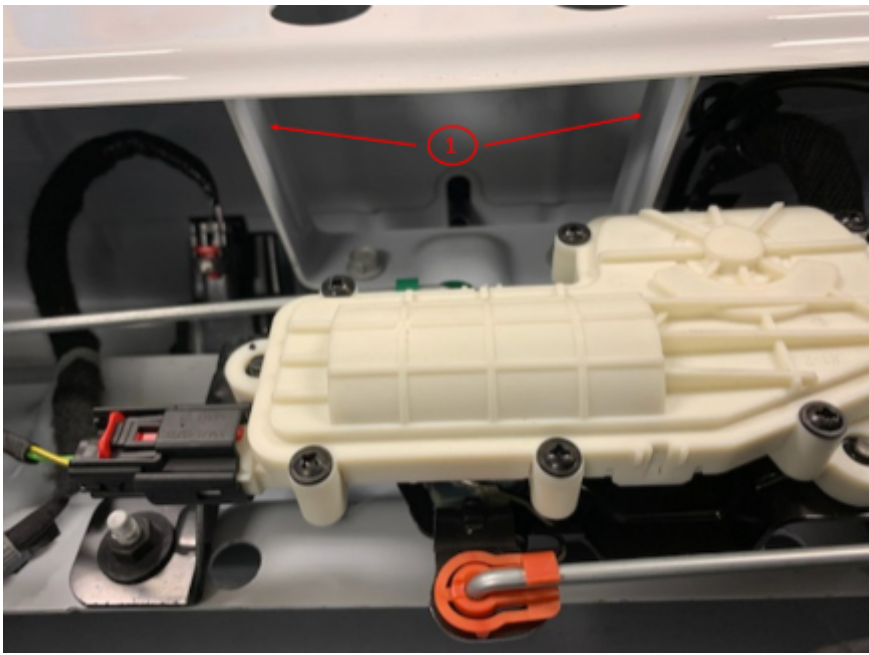
| Condition | Some customers may comment that the tailgate latch handle has disengaged from the tailgate, as shown below. |
| Cause | The cause of this concern could be forces that are applied to a certain area of the tailgate inner panel being transferred through the standoff brackets (1) to the tailgate handle bracket disengaging the tailgate latch handle, shown below. |

To correct this concern, follow the procedure below to remove part of the standoff brackets(1). Removal of the standoff brackets does not hinder the tailgates durability or performance.
