Preliminary Information

PIP5791A DTC P2B60 Engine Coolant Flow Control Valve Position Sensor Circuit Performance

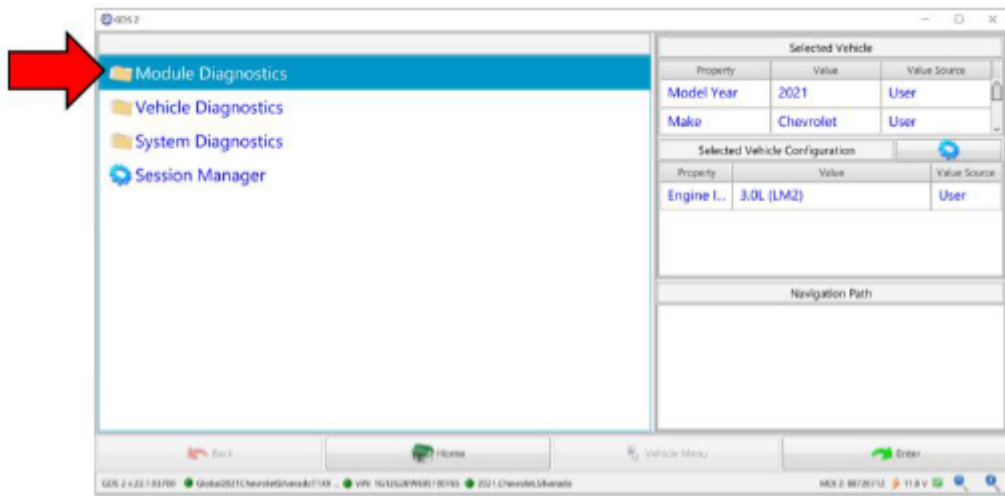
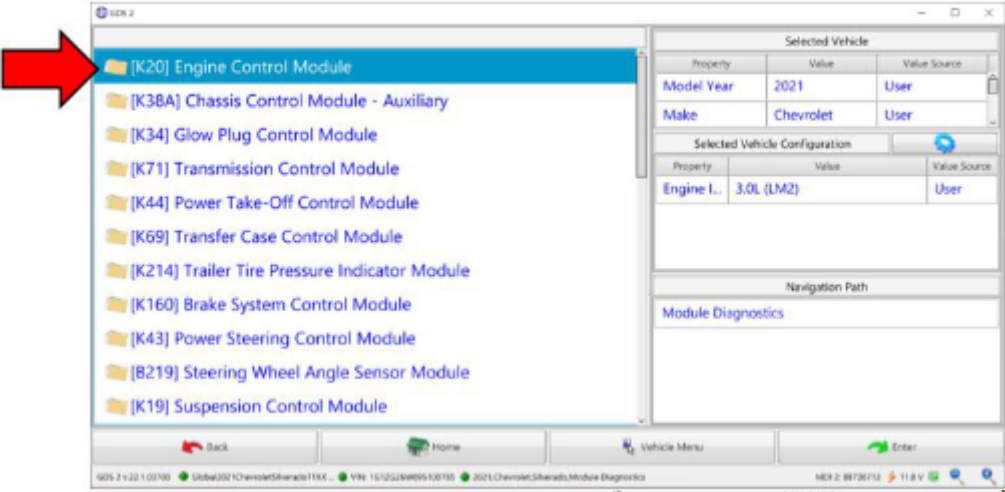
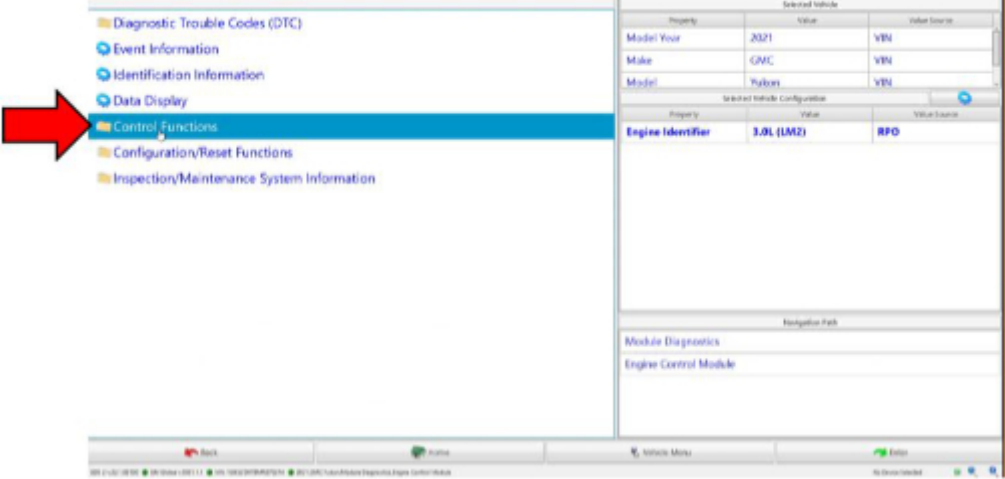
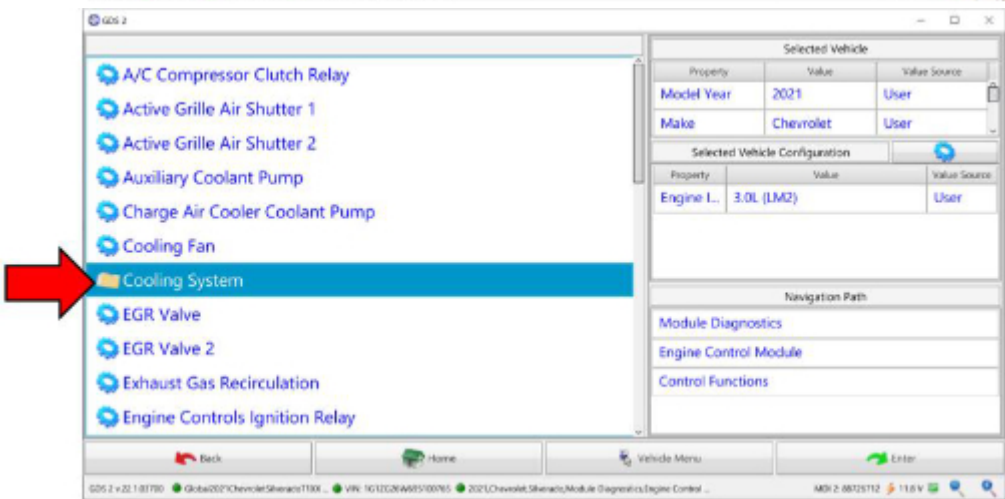
Using the GDS2 tool with software levels greater than GM Global v 2021.3.1 : Perform the following process to evaluate if the Engine Coolant Flow Control Valve is responding. With the ignition on and the engine NOT RUNNING, navigate to the Engine Coolant Flow Control Valve control function as illustrated below.

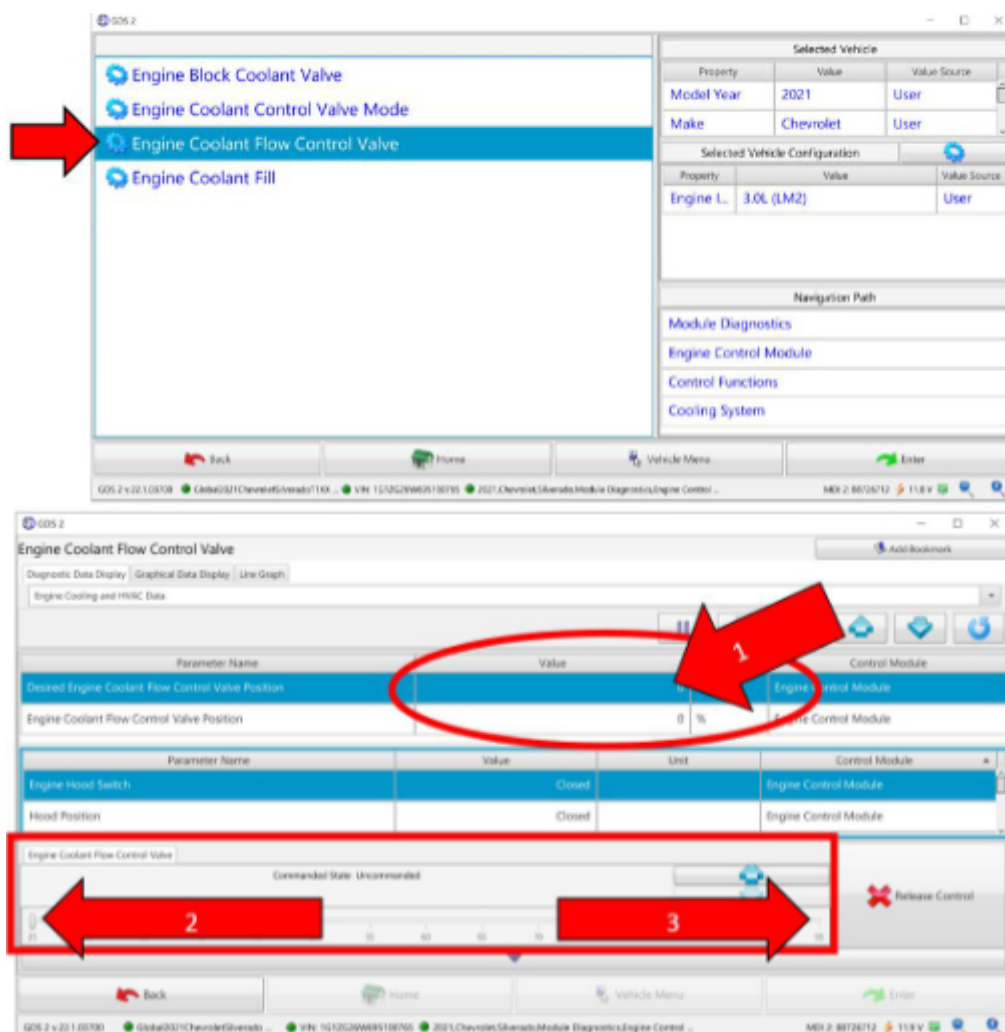
Slide the command from 25% (2) to 95% (3) (for Pickups), making sure to wait until the Engine Coolant Flow Control Position (1) indicates 95% and slide it back to 25% (2). Exercise the valve 3 times to verify it is functional. The “Engine Coolant Flow Control Valve Position” value should move to the desired value just commanded.

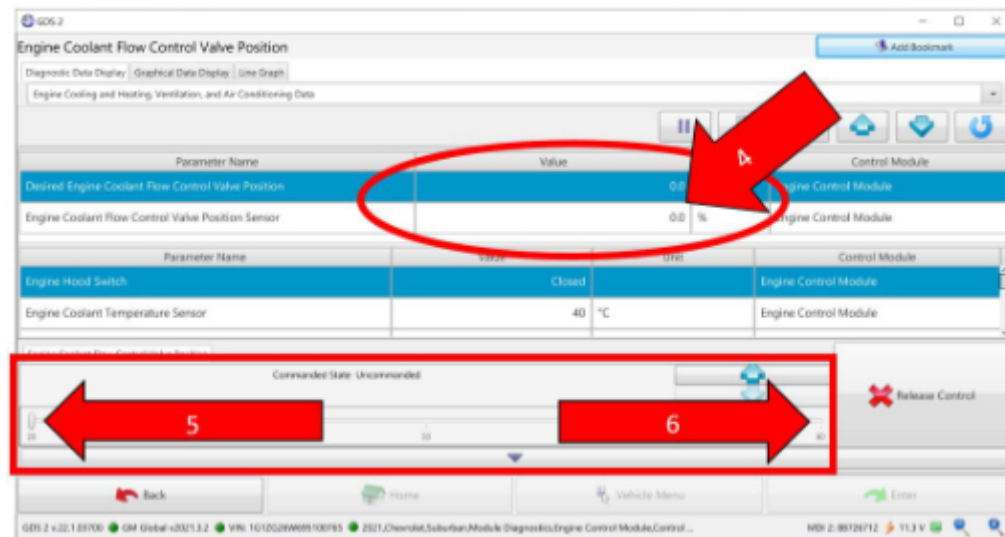
The GDS tool will have a slide range of only 20% - 80% (5 and 6) for an SUV. Please perform the same 3-time-slide action for SUV and verify the Coolant Flow Control Valve position parameter (4) matches the desired position you commanded.

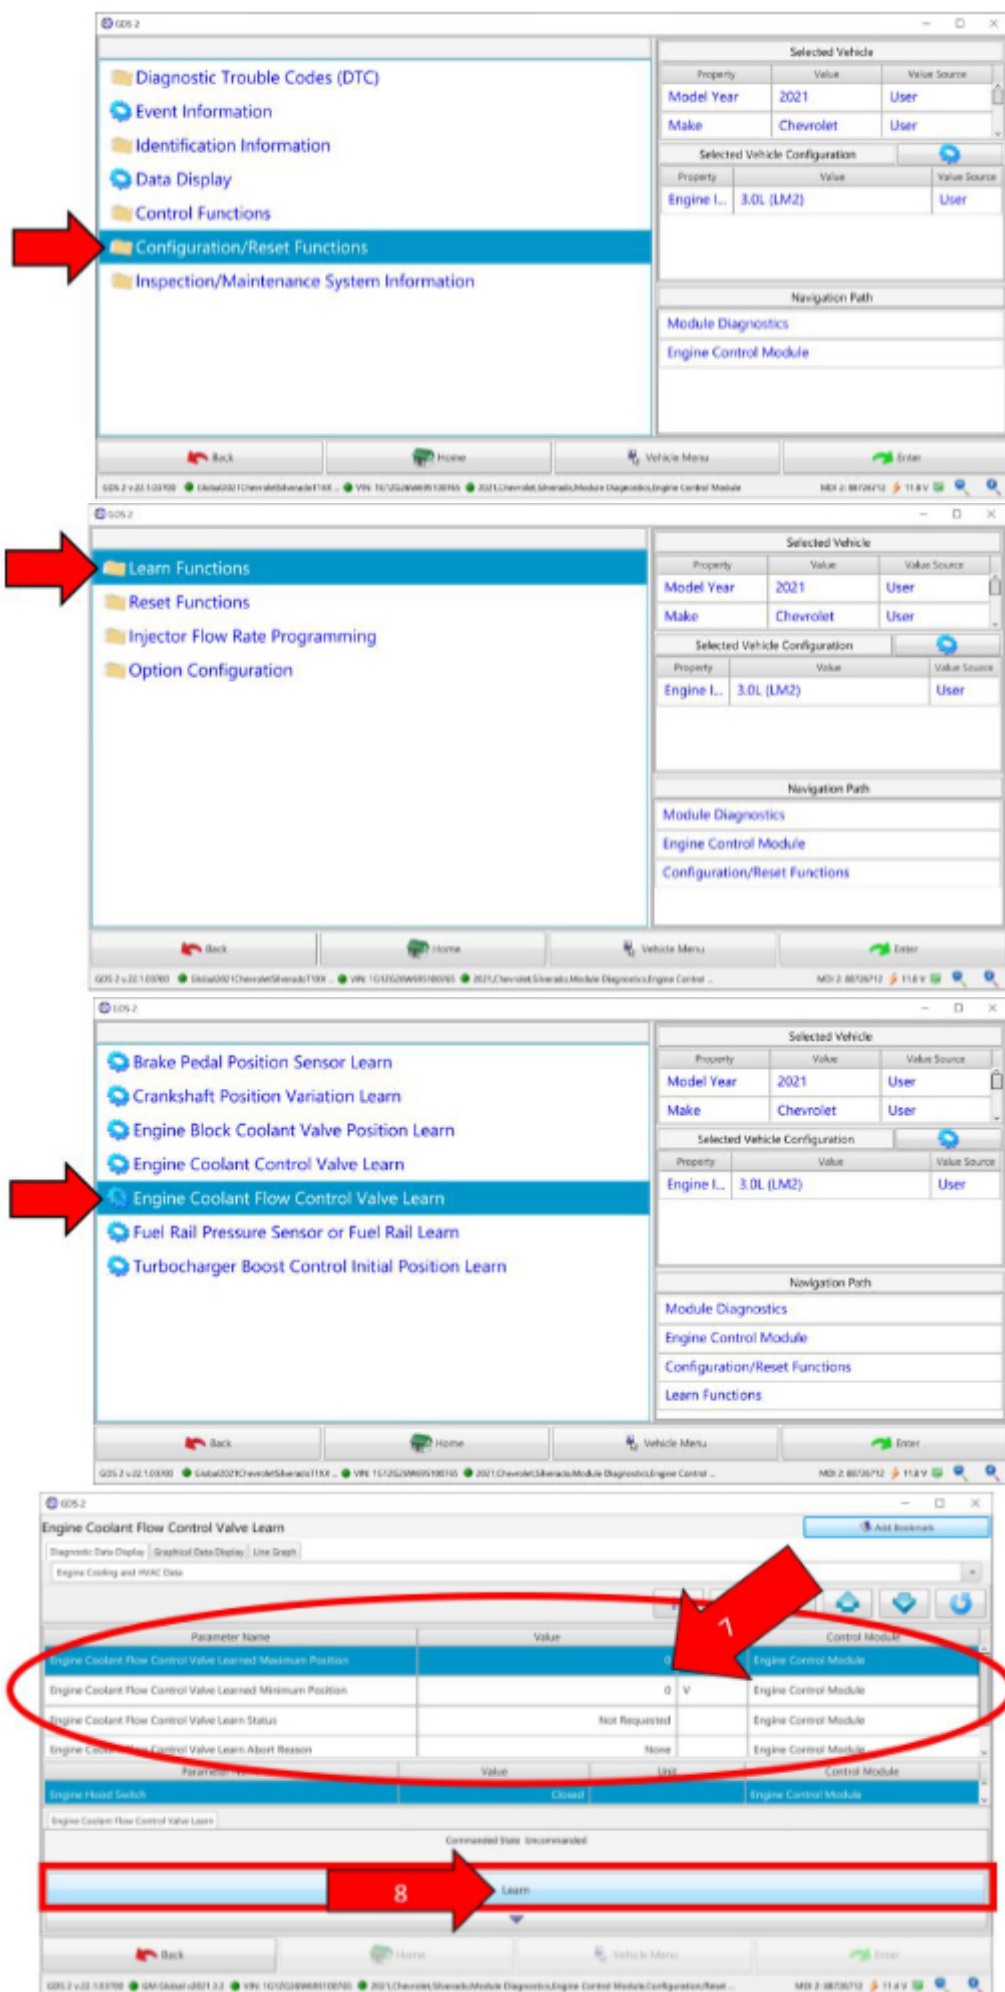
If the valve is responding properly to the command, clear the P2B60 code and perform the Engine Coolant Flow Control Valve learn function as illustrated below:

To perform the learn function: Press the “Learn” button and wait until the progress completes.

After the learn is completed, clear the codes and return the vehicle to the customer.

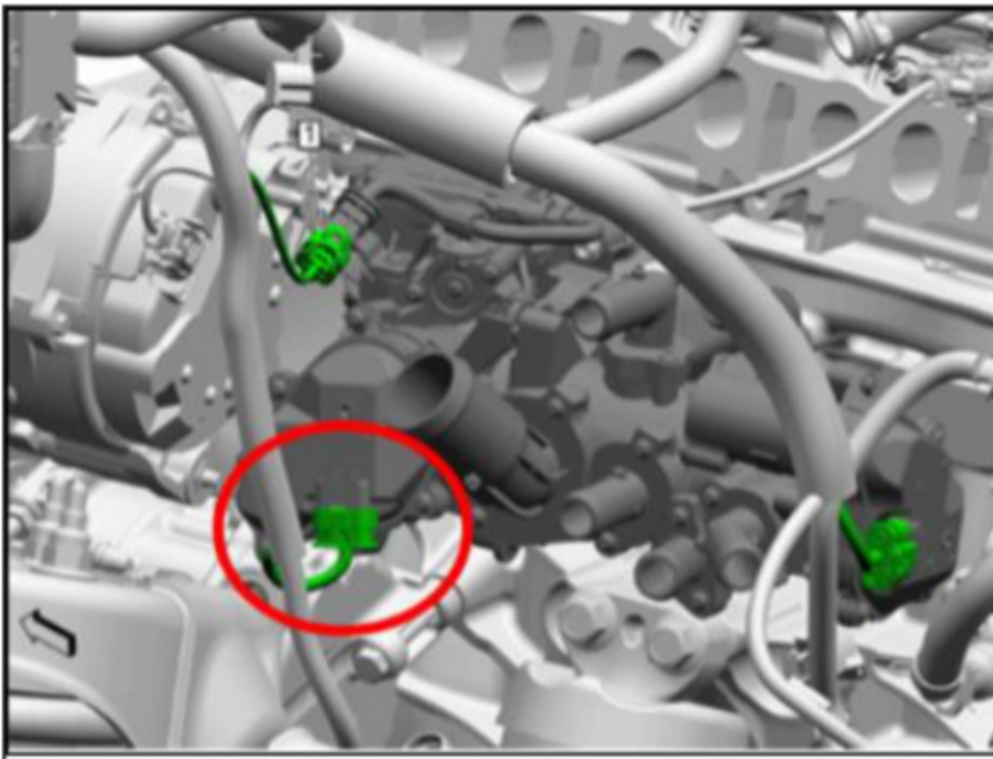
**IF** the valve does not move during the “Engine Coolant flow Control Valve” position command, inspect for corroded terminals at the Engine Coolant Flow Control Valve Actuator connector (it's the center actuator circled below).

1. If corrosion on the terminals is found, replace the harness connector and inspect the Flow Control Valve Actuator pins for corrosion damage.
2. If the actuator pins are corroded, replace the connector and terminals, but DO NOT replace the Coolant Control Valve.
3. If there is no corrosion on the connector terminals or the pins, continue with normal SI diagnostics (PERFORM A LEARN & CLEAR THE CODES).

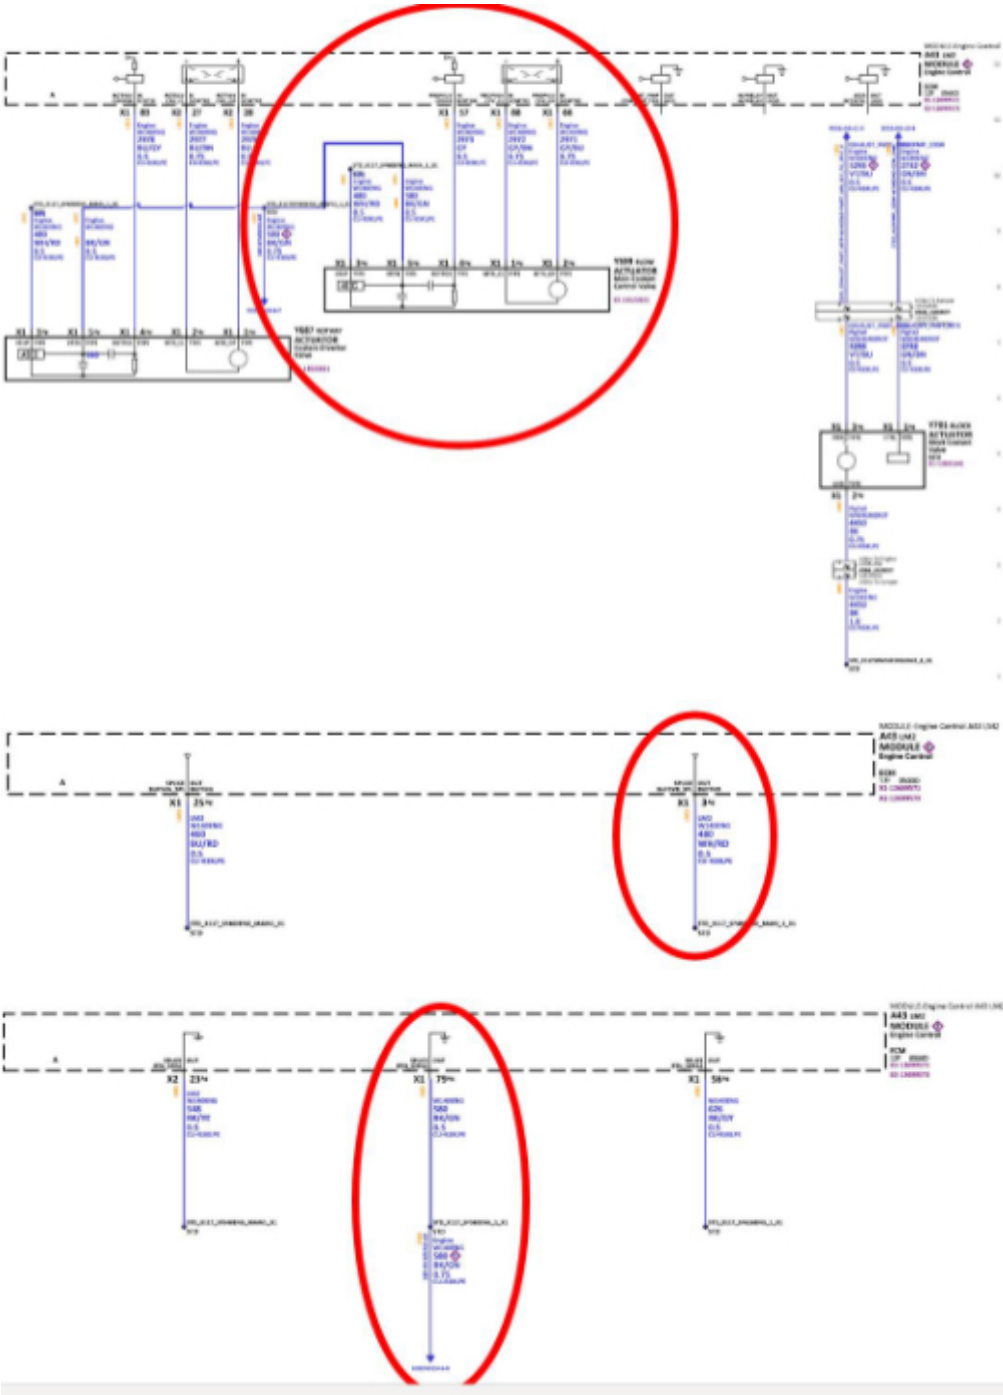
If no issue found with the electrical connector, check the Flow Control Valve circuits (circled in red below).

Replace Engine Coolant Flow Control Valve ONLY IF:

1. The valve fails to respond to the control function AND the circuits are NOT found to be faulty.
2. The circuits are NOT found to be faulty AND it is the second customer visit for this condition where the vehicle was previously released after clearing the P2B60 code with no trouble found.
