Preliminary Information

PIT5866C Multiple Radio Inoperable Issues – IOK Radio

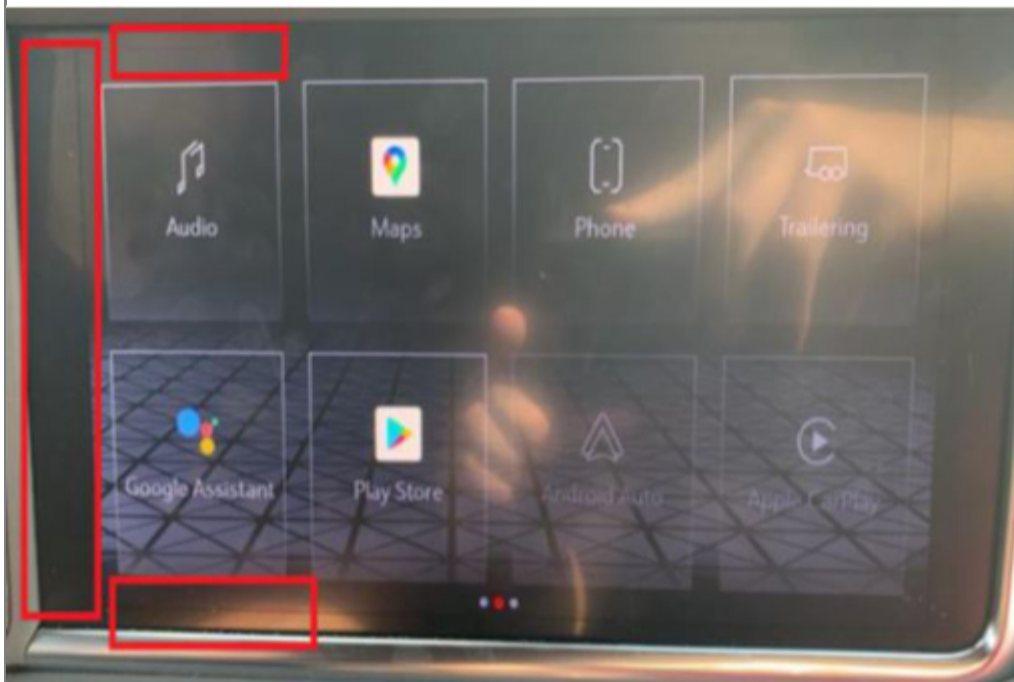
1. **That the home screen bar is missing on the left side of the display.**

EX. Defect

Cause	Condition is occurring in W160.4 software and reason is unknown at this time. Engineering is aware of the issue and is working on a fix.
--------------	---

While engineering is working on a permanent solution, dealers should not replace the radio. Dealers are to use link below to access the data wipe package, which will help to clear the data. Directions for the package are below:

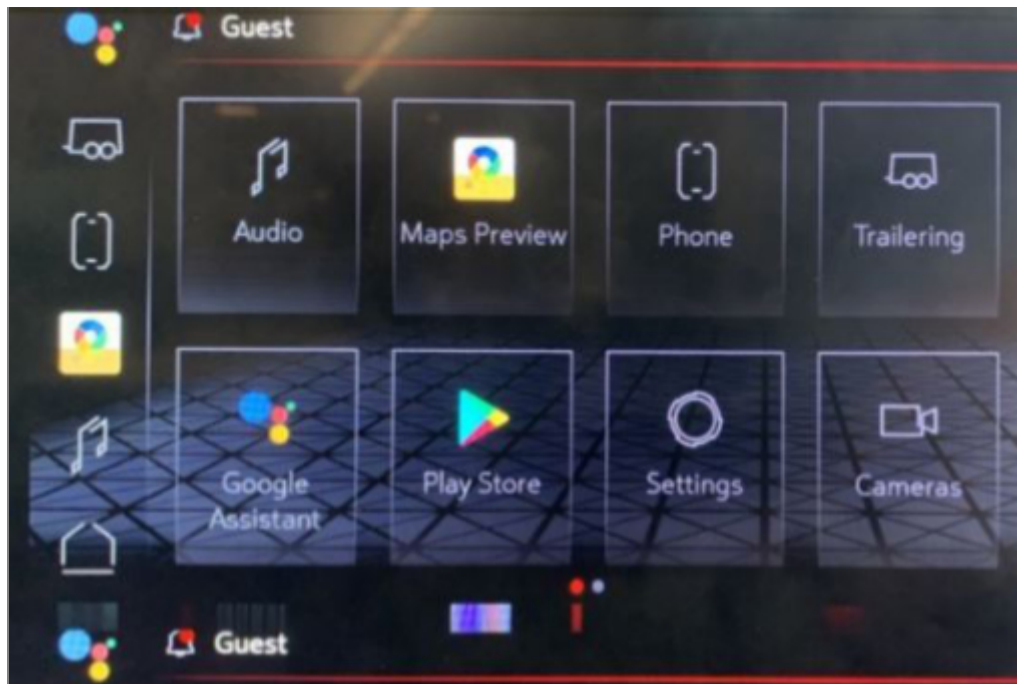
EX. Working

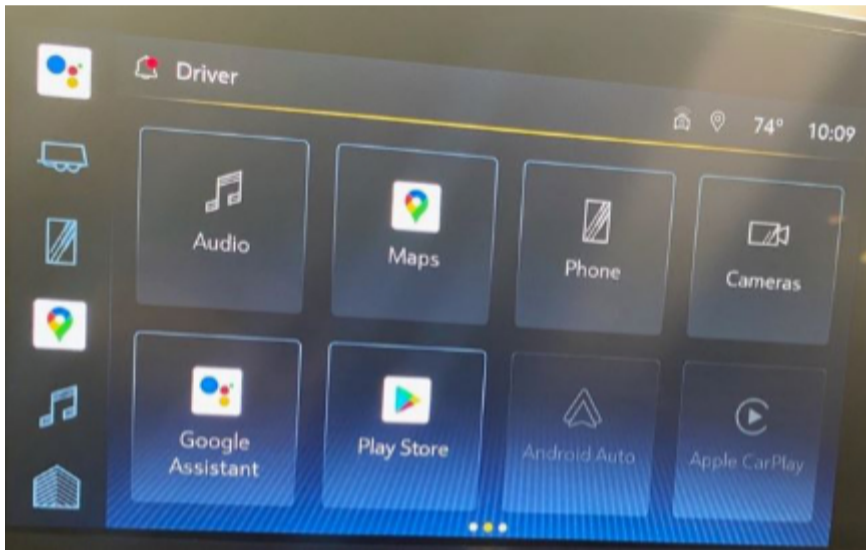
9. Following is the screenshot of a good working case.
