Preliminary Information

PIP5817B Hot Idle Tick Noise from Engine

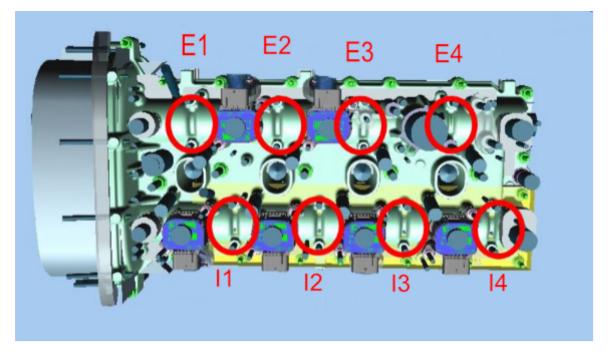
Some customers may have a concern of tick noise at hot idle from the upper engine.

This noise will occur at valve train speed, increase and decrease with RPM and may become louder as the engine temperature increases.

Carefully place the tip of a stethoscope at the locations shown below to isolate the area of the noise.

Once the noise is isolated, remove the Camshaft Carrier Cover following all GSI procedures.

Replace either the Intake Camshaft or Exhaust Camshaft based on the location of the noise isolated using the Stethoscope.
