# TECHNICAL SERVICE BULLETIN

## 10R140 Automatic Transmission – Transmission Fluid Leak At The Bellhousing Area - Built On 01-Dec-2021 And Through 15-Dec-2021

**22-2030**

07 February  
2022

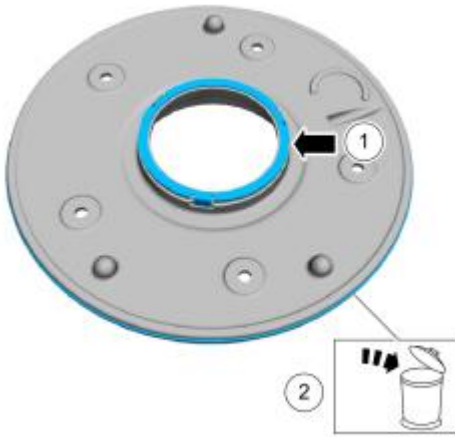
Figure 8

**Issue:** Some 2022 F-Super Duty vehicles built on 01-Dec-2021 and through 15-Dec-2021 equipped with a 10R140 transmission may leak from the bellhousing of the transmission. This may be caused by an oversized bore in the front support cover. To correct the condition, replace the torque converter hub seal and the front support cover.

11. Discard the old front support cover and seal. (Figure 8)
