TECHNICAL SERVICE BULLETIN

Technical Service Bulletin: T67

Firefly Integrations (who provide the programming and hardware for the switches and touchscreen in your coach) is alerting you to an issue involving certain Cedar Creek fifth wheels. Please see the information below which describes the issue and provides you with details on the steps you should take to have your vehicle repaired.

Firefly Integrations has identified that fluid tank sensor readings will display 100% after being filled but will incorrectly change to 67% once the tanks have settled.

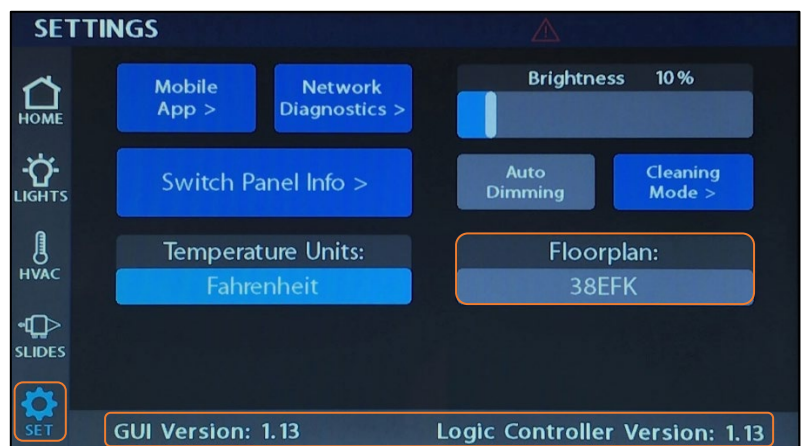
Note: Before visiting the website or calling for a consultation, please note the Floorplan and GUI/Logic Controller version numbers (located on the Settings page of your touchscreen).

Example – Floorplan 38EFK and GUI/LC 1.13
