# Customer Satisfaction Program

## N212355910 Turn Signals Remain On After Passive Door Locking

Release Date: February 2022

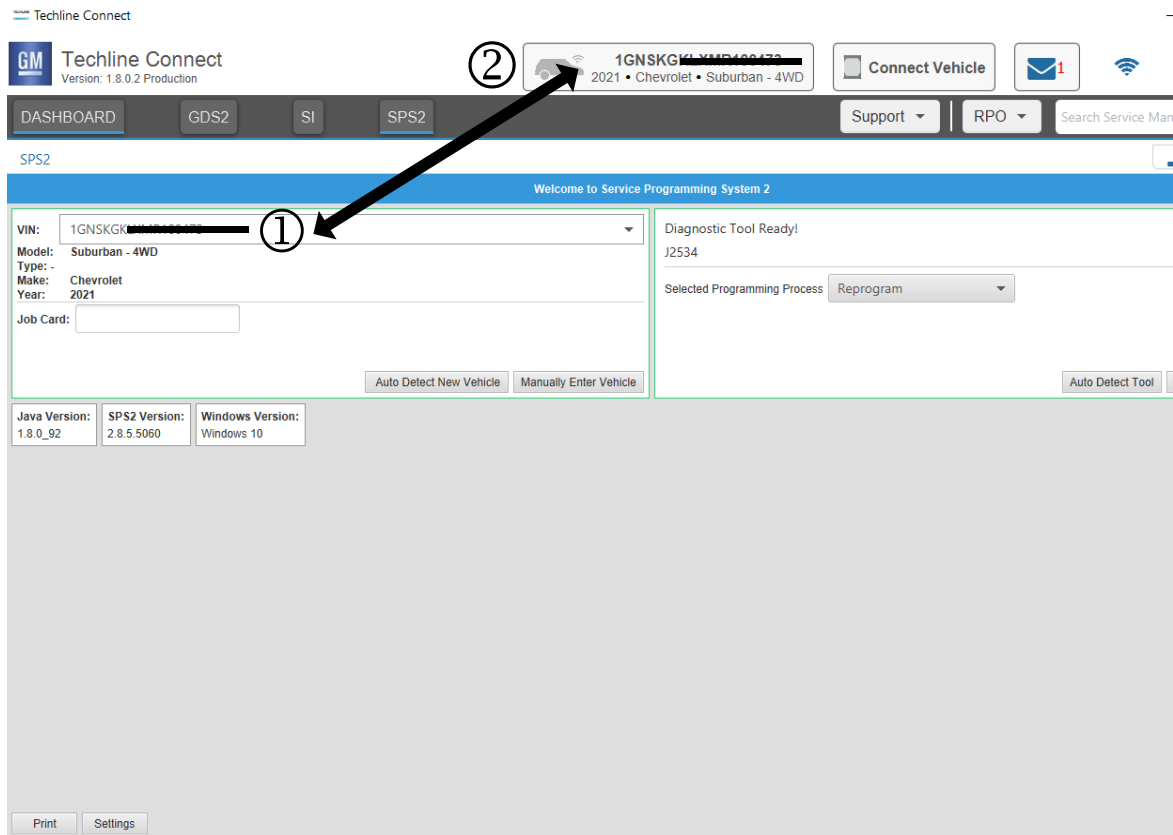
5743643

**Caution:** Be sure the VIN selected in the drop down menu (1) is the same as the vehicle connected (2) before beginning programming.

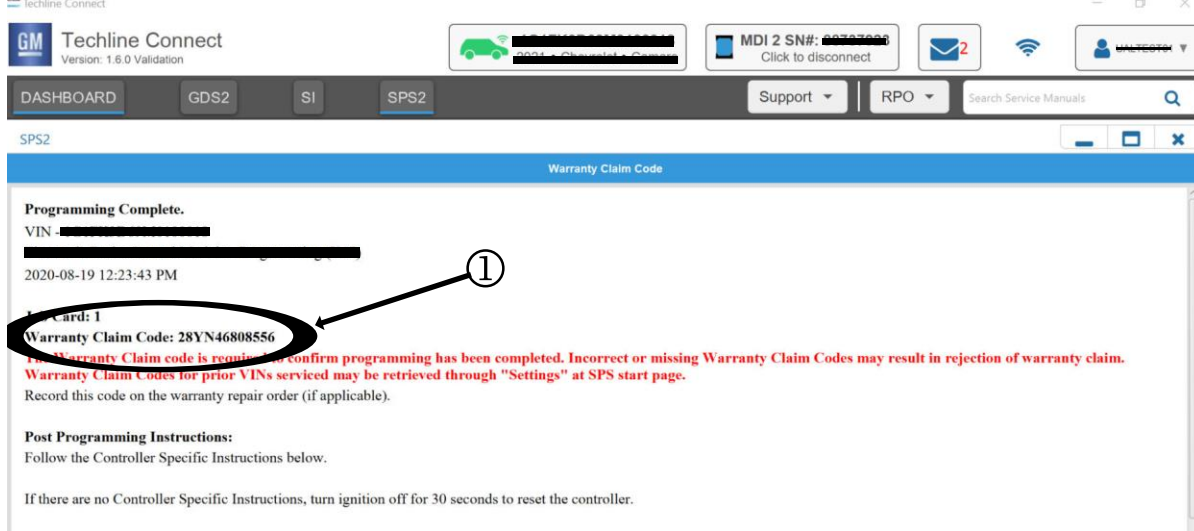
5644478

**Note:** The screenshot above are an example of module programming and may not be indicative of the specific module that is being programmed. Module selection and VIN information have been blacked out.

**Important:** To avoid warranty transaction rejections, you **MUST** record the warranty claim code provided on the Warranty Claim Code (WCC) screen shown above on the job card. Refer to callout 1 above for the location of the WCC on the screen.

1. Reprogram the Body Control Module. Refer to *K9 Body Control Module: Programming and Setup* in SI.

2. Record SPS Warranty Claim Code on job card for warranty transaction submission.
