## Service Update N222358630 Hands Free Liftgate Not Operating

### Release Date: February 2022

Models: 2022 GMC Terrain

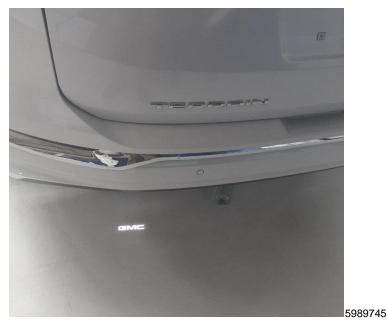
Note: Be sure to have the vehicle key fob within 3 feet of the rear fascia when verifying the liftgate hands free operation.

- 1. Verify rear liftgate hands free operation by using kicking motion under the rear bumper between the left exhaust pipe and the license plate. There should also be a "GMC" logo that will shine on the ground. The logo may be difficult to see in high ambient light areas
  - 1.1. If the rear liftgate operates as instructed, no further action is required.
  - 1.2. If the rear lift gate DOES NOT operate and the GMC logo is not shining on the ground, proceed to step 2.
- 2. Replace the Rear Closure Hands Free module. Refer to Rear Closure Hands Free Module Replacement in SI.
