SIB 62 01 22

2022-01-05

INSTRUMENT CLUSTER VERSION MID BLACK SCREEN

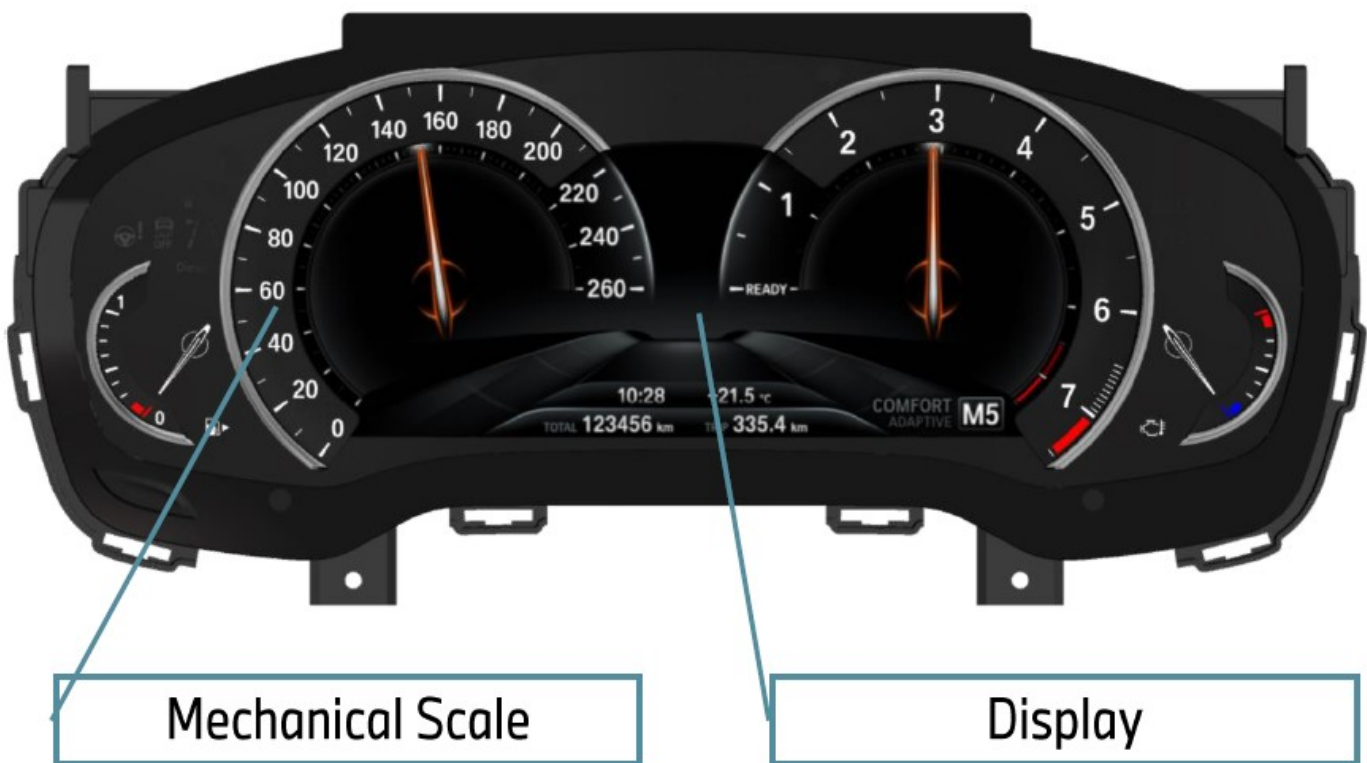
Kombi MID ON

This only affects vehicles with instrument cluster version MID Generation 4 (Kombi MID); reference the image below to identify the correct instrument cluster.
