Technical Service Bulletin

92 Repairing corrugated hose for windshield washer system

92 22 28 2065963/1 February 8, 2022.

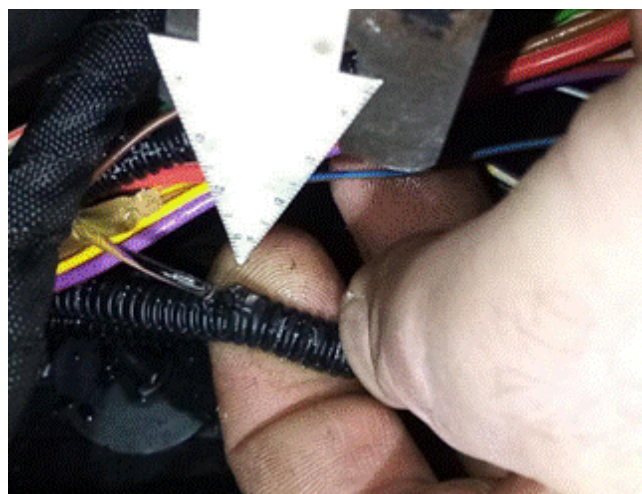
A windshield washer solvent leak has developed in the corrugated windshield washer hose inside the cabin, specifically the hose that is wrapped among the wiring harness bundle. See figures 1 and 2 for examples of the damage.

Figure 1. Rupture in corrugated windshield washer hose accompanied by a wiring abrasion.

1. Before repair, additional information is required. Please take photos clearly showing the damage (at a distance and close-up) and post them to DoClt. After this documentation is posted remove a section of the corrugated washer hose that contains the damage 50 mm to each side of the damage. The removed section will then be 100 mm and contain the damaged area. This section will be requested for return to the WPRC to assist us in gathering additional information for the investigation.

2. Elsa describes the repair procedure for ruptured corrugated windshield washer hoses using the following navigation path:

4. Make all necessary repairs including any wiring damage. Package the removed washer hose section and retain for WPRC request for return.

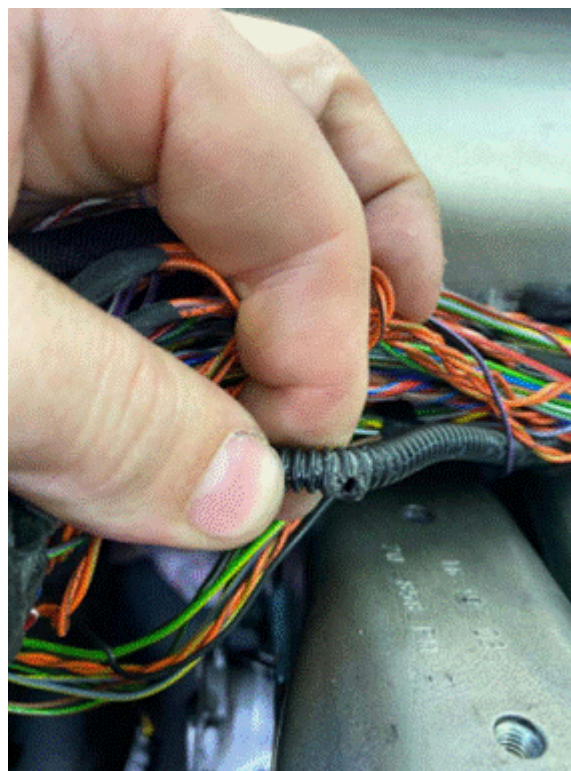
Figure 2. Ruptured corrugated windshield washer hose.
