# Technical Service Bulletin

**92 Headlight washer jet does not retract**  
**92 22 29 2065982/1 February 8, 2022.**

| Model(s) | Year | VIN Range | Vehicle-Specific Equipment |
|---|---|---|---|
| A6 | 2019 | All | Not Applicable |

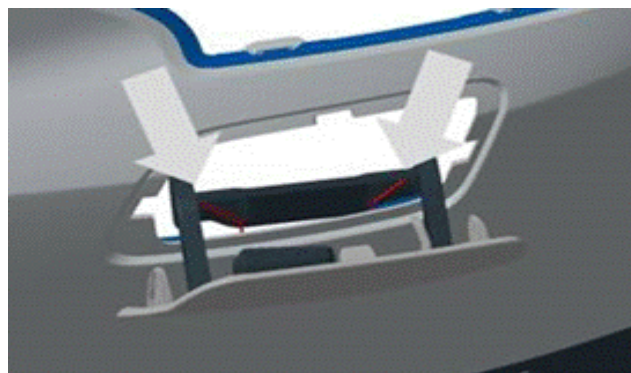
This issue may be due to a headlamp washer system nozzle cover return spring exerting too great a force and may prevent the nozzle from retracting.

If the symptom described in this TSB is duplicated, make an attempt to relieve the pressure exerted on the headlamp washer system nozzle cover with your finger. If the nozzle retracts on its own check the cover spring clip version. Figure 2 shows the old version which has been found to exert excessive pressure and prevent smooth nozzle retraction.

*Figure 2. Old version cover spring clip.*

If the old spring clip version is installed and the nozzle retracts on its own after relieving the cover pressure, replacing the spring clip may solve the problem. Replace the spring clips for both the left and right sides in this case. Only the improved version spring clip is available.

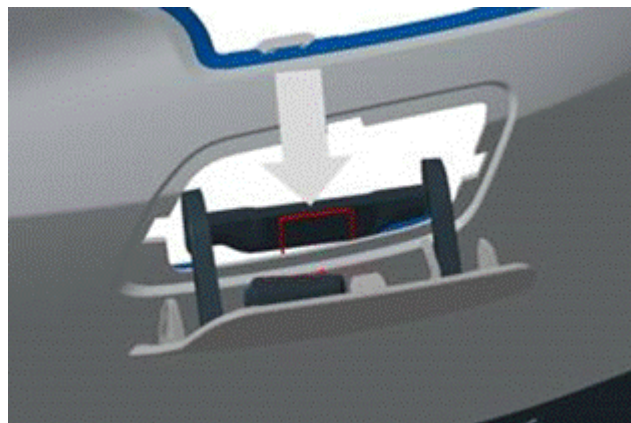
Figure 3 shows the improved spring clip with reduced tension.

*Figure 3. Improved version cover spring clip.*

If the nozzle does not retract after relieving the cover pressure and / or the spring version installed is of the improved type, continue root cause diagnosis as the solution specified in this TSB will not aid in solving the problem.
