GLOBAL SAFETY FIELD INVESTIGATIONS
DCS6060
URGENT - DISTRIBUTE IMMEDIATELY

Subject: N222359350 - Service Update
Transmission Fluid Potential Leak at the Pipe to Accumulator
– US Only

Models: 2022 Chevrolet Equinox
Equipped with a Engine-Gas, 4 CYL, L4, 1.5L, Transmission-Auto 6
SPD (RPO LYX, MNH)

N222359350 Transmission Fluid Potential Leak at the Pipe to Accumulator

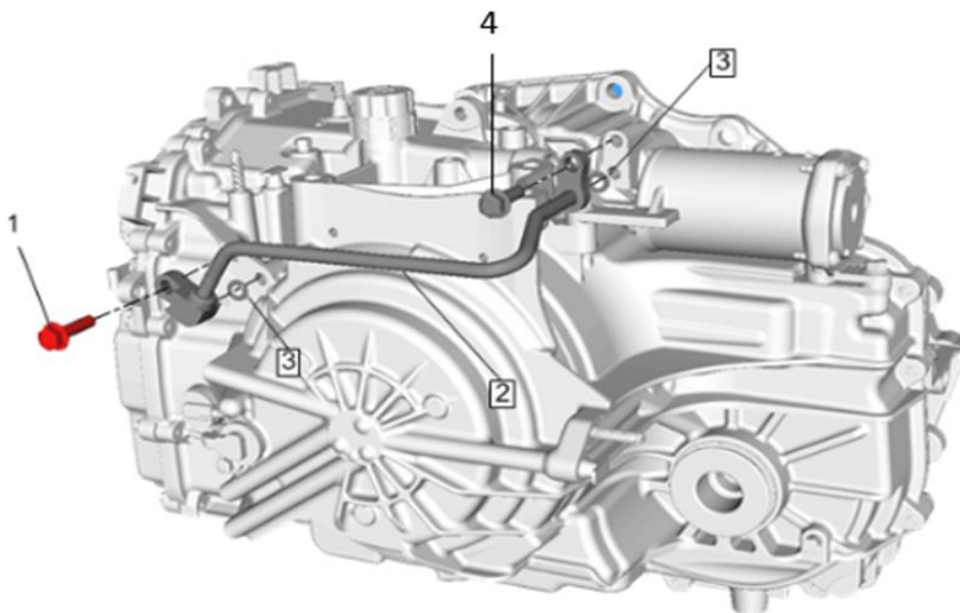
5992723

Condition	Certain 2022 model year Chevrolet Equinox vehicles equipped with a gas engine and six-speed transmission, may have a slow dripping leak between the transmission case cover and the pipe to the accumulator due to insufficient pressure on the slimline seal washer at the case. This is caused by excess friction in the tapped hole.
Correction	Dealers are to inspect for a leak and verify torque to upper end of specification.

3. Tighten the bolt indicated by (1) to 25 N-m (18 lb ft).
4. Reinstall the Front Wheelhouse Liner – Left Side. Refer to *Front Wheelhouse Liner Replacement - Left Side* replacement in SI.
5. Reinstall the battery tray. Refer to *Battery Tray Replacement* in SI.
