Reactive Coverage for Bell 4000 Series™ Torque Converter Lockup Piston

MODELS AFFECTED: 4700/4800 Off Road Series™ (ORS)

VOCATIONS AFFECTED: Articulated Dump Truck

SERIAL NUMBERS AFFECTED: 6620026363 – 6620039426

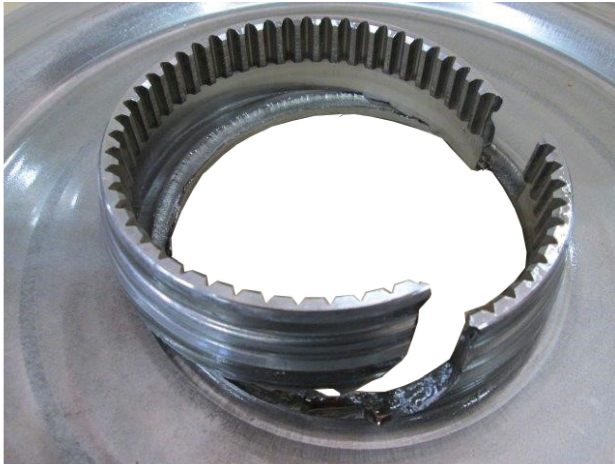
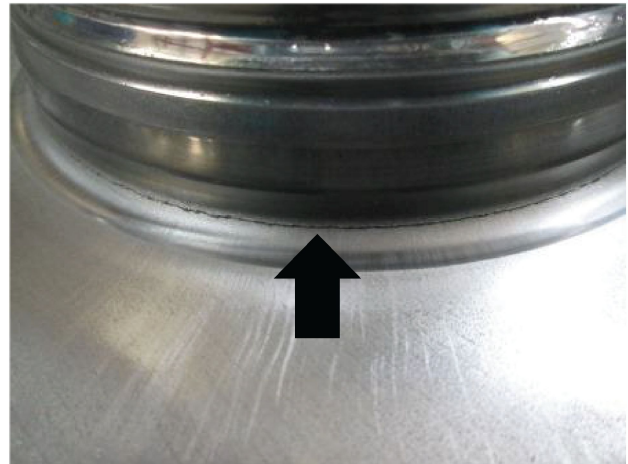
5874345

This Field Action only covers the below condition that can affect the torque converter lockup piston. Cracking of the lockup piston along the radius below the spline, seen in [Figure 0](#), will cause low lockup pressure and can cause the following symptoms:

- Lockup not obtained due to low lockup pressure
- DTC P0741 Torque Converter Clutch (TCC) System Stuck Off
