Technical product information

Topic	Night vision camera - Washer jet leaking
Market area	Bentley: worldwide (2WBE),Hongkong-Macau (5HK)
Brand	Bentley
Transaction No.	2051045/5
Level	EH
Status	Approval
Release date

Bentayga - New GT/C - New Flying Spur

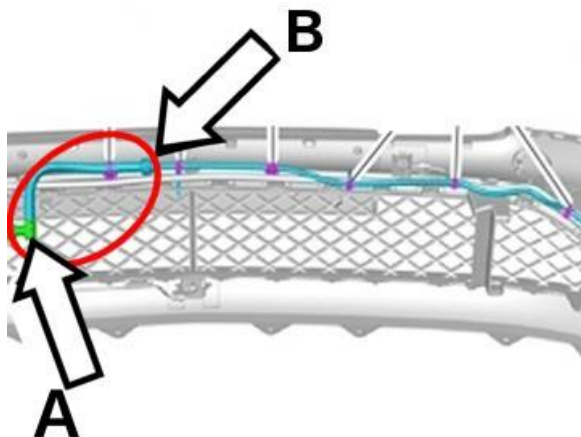
Washer fluid dripping/leaking from the night vision camera washer jet

Referring to Figure 1 - In the event the afore mentioned symptom is evident the operative should refer to the Measure section of this TPI to replace the night vision washer jet (short link hose - Circled) which connects the night vision camera washer jet (A) to the washer jet supply hose connector (B)
