**Subject: M2 Front Steer Arm – Drag Link Ball Joint
Connection Inspection**

Models Affected: Specific Freightliner M2 vehicles manufactured between April 1, 2018 and July 14, 2020.

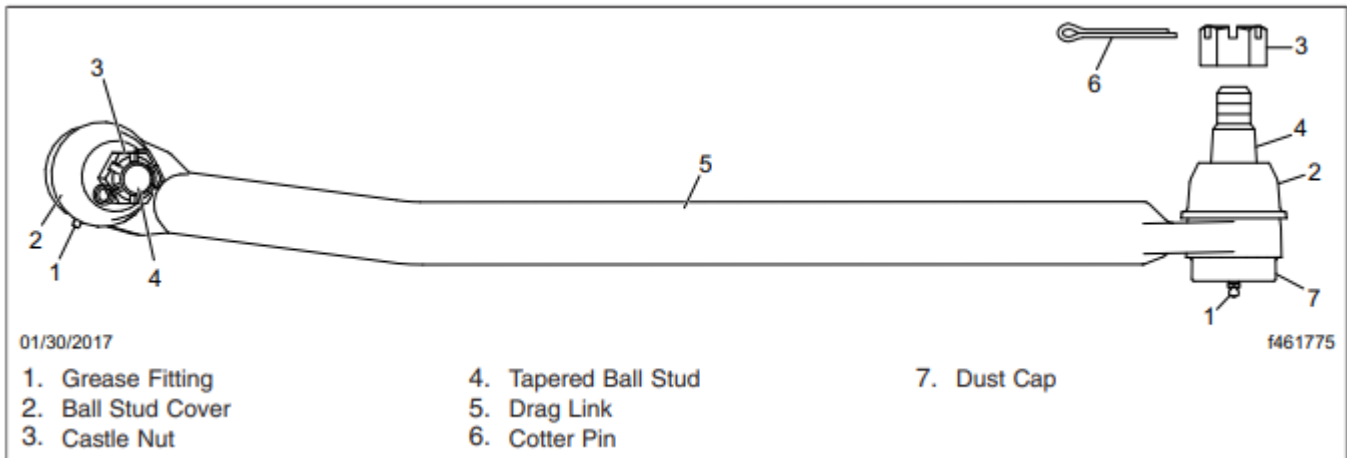
Fig. 2, Fixed-Length Drag Link Assembly

6. If relative movement is observed between the drag link ball stud and steering arm connection point, the drag link and steering arm will need to be replaced. Notify DTNA of the issue including the VIN of the vehicle on which the issue was found.

- 5.2 Once the castle nut is tightened, install a new cotter pin. If the new cotter pin does not align, continue to tighten the castle nut to achieve cotter pin alignment. **Do not** loosen the castle nut to allow for alignment of the cotter pin.

- 6.1 For steering arm replacement refer to the following manual sections:
- *Business Class M2 Workshop Manual*, Section 33.03, Subject 110 Detroit Front Axles, Axle Removal and Installation.

- *Meritor Maintenance Manual 2* for Meritor Front Non-Drive Steer Axles, section 10.
- 6.2 For drag link replacement refer to the *Business Class M2 Workshop Manual*, Section 46.01, Subject 100 Drag Link and Tie Rod, Drag Link Removal and Installation.

- If replacing the drag link, tighten the castle nut to the value listed in **Table 1** and align the cotter pin according to the instructions in step 5.2.
