Technical product information

Topic	Fuel pressure regulator - DTC P242200 with symptom code 14536 evident within address 0001
Market area	Russische Föderation (5RU),Australia E04 Bentley rest Asia and Australia (6E04),China 796 VW Import Comp. Ltd (Vico), Beijing (6796),Germany E02 Bentley rest Europe (6E02),Japan E03 Bentley Japan (6E03),Korea, (South) E08 Bentley South Korea (6E08),United Arab Emirates E06 Bentley Middle East and Africa (6E06),United Kingdom E01 Bentley UK (6E01),United States E05 Bentley USA and rest America (6E05)
Brand	Bentley
Transaction No.	2065926/1
Level	EH
Status	Approval
Release date

Bentayga Hybrid

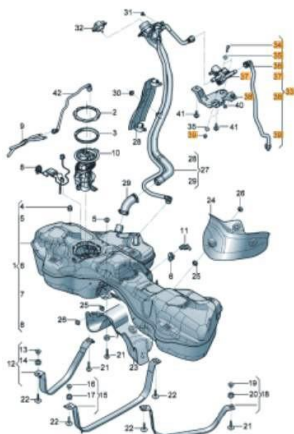
4M0 201 549A - Pressure regulator assembly and associated parts as shown below

33	4M0 201 549 A	pressure regulator	
34		Oval hexagon socket head bolt	M6X30 Included in position: 33
35		Washer	M6 Included in position: 33
36		Breather line	Included in position: 33
37		pressure regulator	Included in position: 33
38		Bracket	Included in position: 33
39		Hexagon collar nut self-locking	M6 Included in position: 33

- 1) Referring to Rep.Gr 20- Replace the Pressure regulator assembly and associated components
- 2) Conduct a road test in EV Mode and/or Hybrid drive mode where possible
- 3) On return from road test - Check to confirm the issue is resolved and DTC P242200 is not evident within address 0001
