Technical Service Bulletin

90 Audi connect user management option greyed out or SOS and Roadside with no function

90 22 46 2052299/4 February 22, 2022. Supersedes Technical Service Bulletin Group 90 number 18-05 dated October 23, 2018 for reasons listed below.

Model(s)	Year	VIN Range	Vehicle-Specific Equipment
All	2019 – 2022	All	Not Applicable

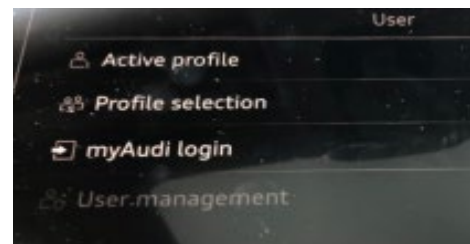
Figure 1. User management.

- The Audi connect “User management” screen is greyed out and the customer cannot complete the key user pairing (Figure 1).

Change the adaptation for flight mode in diagnostic address 0075 at, *Self-diagnosis >> Go to address 0075 >> Adaption values "Basis connect function" >> Flight mode >> Deactivate.*

Hit "Apply".

Cycle the ignition off and then back on.

Within Self-diagnosis go to DTC readout for diagnostic address 0075 and clear the DTC.

Verify the SOS light is green and/or the Audi connect User management option is now selectable.

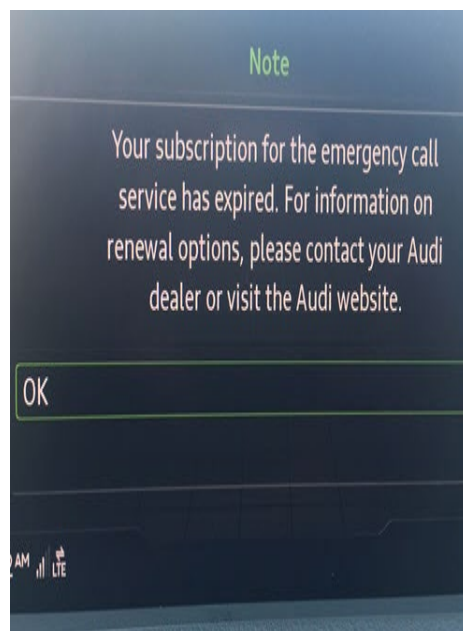
Figure 2. Error message in MMI.

- The SOS emergency button is red or flashing red. When the customer presses the button an error message of “Your subscription for the emergency call service has expired” (Figure 2) is seen.
